January 27, 2005

SUBJECT: Safety Recall 05S28:
Certain 2000 Model Year F-150, Expedition, Navigator, and 2001 F-150 SuperCrew
Vehicles Equipped With Speed Control
Speed Control Deactivation Switch Replacement

CERTAIN 2000 MODEL YEAR F-150, EXPEDITION, NAVIGATOR AND 2001 F-150 SUPER CREW VEHICLES EQUIPPED WITH SPEED CONTROL OPTION — SPEED CONTROL DEACTIVATION SWITCH REPLACEMENT — INTERIM REPAIR

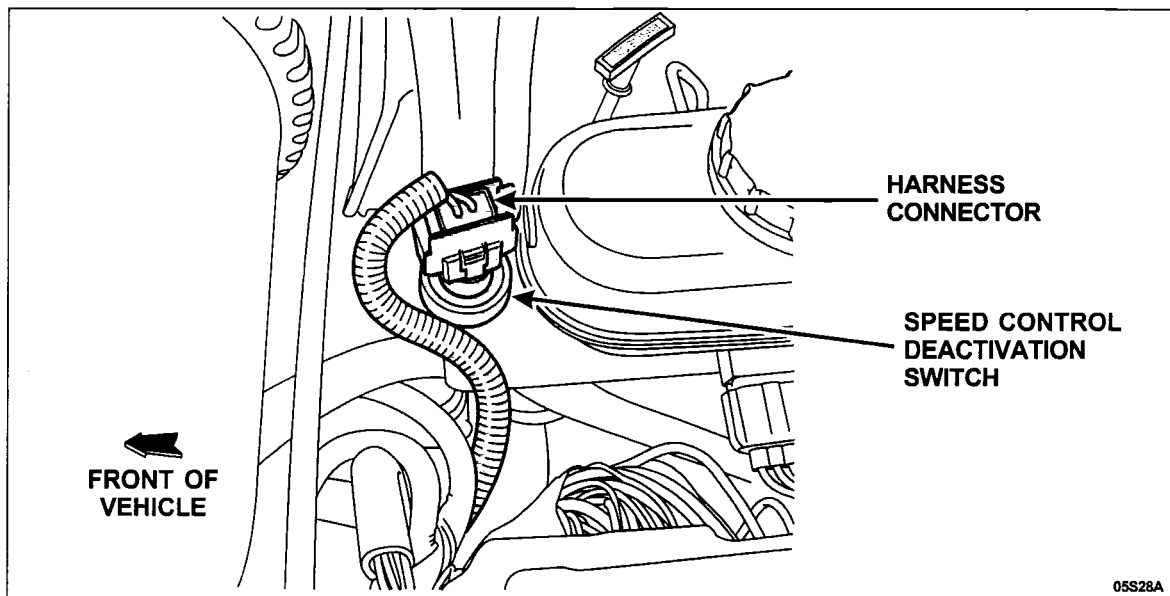
FIGURE 1

The speed control deactivation switch may, under certain conditions, overheat, smoke, or burn.

1. Disconnect the speed control deactivation switch harness connector located on the brake master cylinder. See Figure 1.
