DUCATI NORTH AMERICA, INC.

| Service Bulletin | RCL-05-004 |

Subject: Update: Monster Rocker Arm Recall *Updated Part Number

Models: Monster 620 - S2R MY 2005

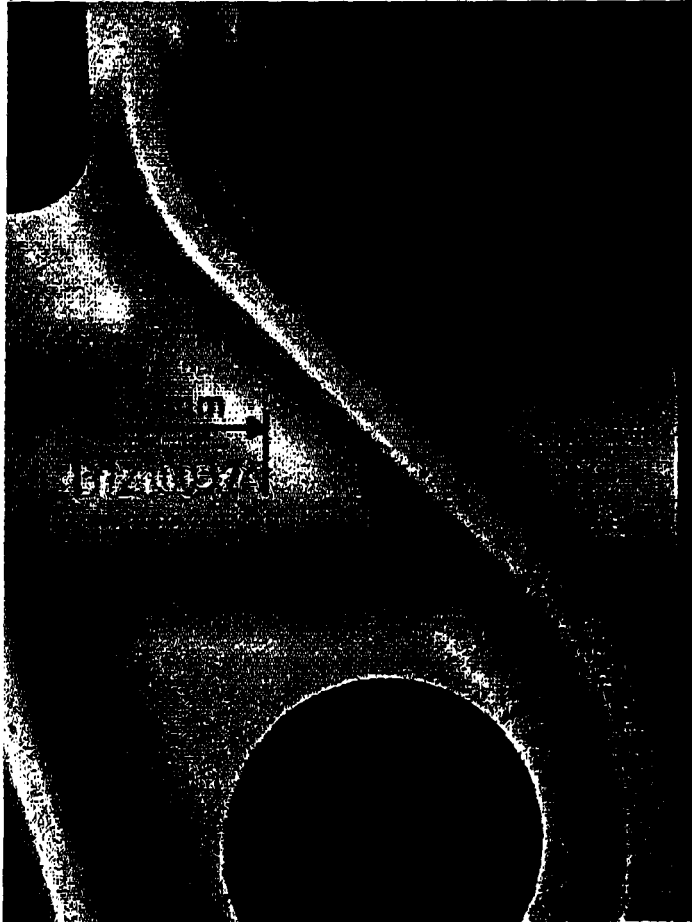
Ducati Motors S.P.A. has determined that it is possible that the incorrect rear shock absorber rocker arm part number 37210032A was installed during production of the above mentioned motorcycle models. The incorrect component could potentially fail causing the vehicle to crash without prior warning.

Review attached affected VIN List to determine if the vehicle is potentially affected by the condition described above. (faxed bulletins will not include list [due to size] Please see dealer portal at ducatiusa.com + a hard copy will be mailed to your dealership. The length of the part number code printed on the rear shock absorber rocker arm must be measured. The correct length of the printed part number must be 21 mm. (See Picture Below)
