**Early 2005 Avalon Steering Column Assembly Inspection**  
**\*\*\*\*\*URGENT\*\*\*\*\***

SUBJECT: SPECIAL SERVICE CAMPAIGN (SSC) – 50F  
(EARLY 2005 MODEL YEAR TOYOTA AVALON STEERING COLUMN ASSEMBLY  
**INSPECTION**)

**TECHNICAL INSTRUCTIONS**

**2005 MODEL YEAR AVALON**  
**STEERING COLUMN ASSEMBLY INSPECTION**

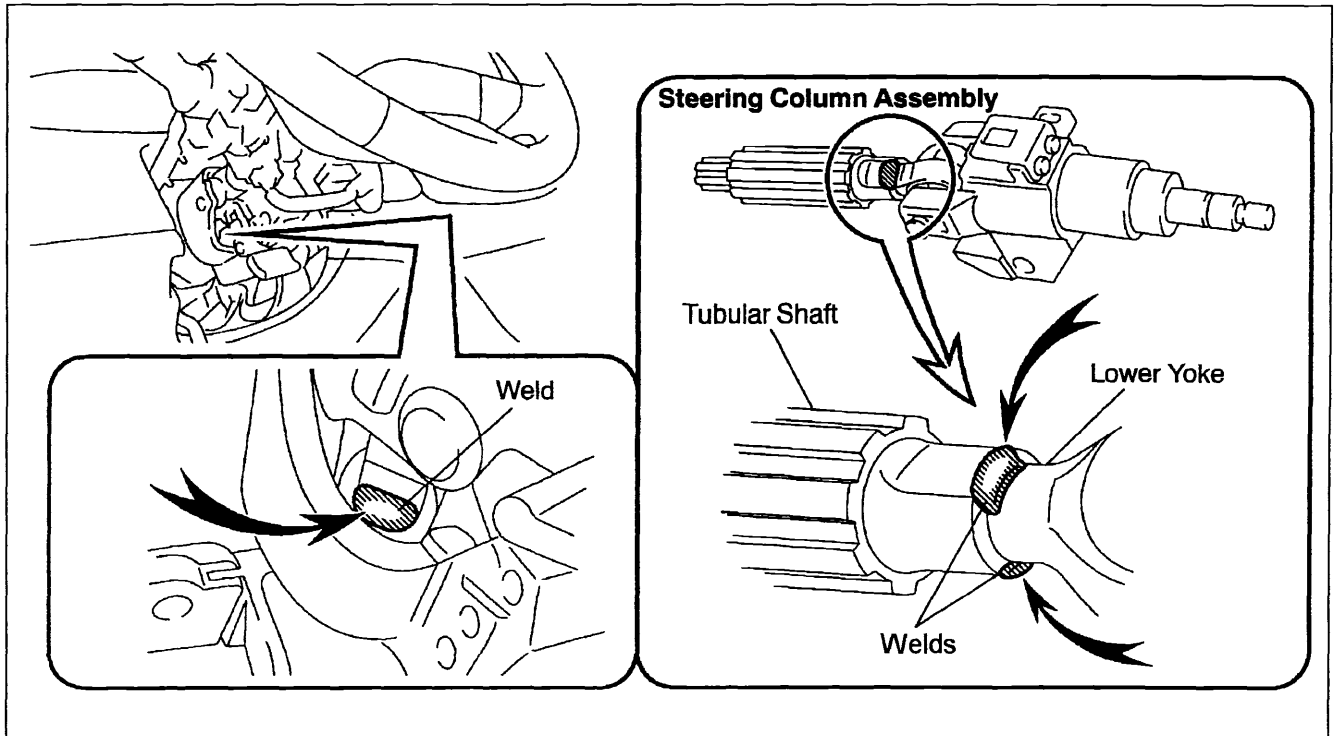
## 2. INSPECT THE STEERING SHAFT

- (a) Locate the opening on the steering column as shown in the illustration below, and insert the special flashlight.
- (b) Check that there are welds (see TIS video clip) present on the flat areas of each side of the shaft between the lower yoke and the tubular shaft, as shown in the illustration.

### Weld marks are missing:

- Steering column assembly is **NG**.
- Please call S. Brand in Quality Compliance at 310-468-7966.

Steering columns that are replaced will be placed on Warranty Parts Recovery and dealers will be required to return the original parts to TMS for inspection. Parts that are not returned or were unnecessarily replaced will result in the claim being debited.
