SUZUKI MOTOR CORPORATION  
SERVICE DEPARTMENT

**RE: Recall Campaign for VZ800, VL800/T/Z K5/6 Ignition Switch**

## VZ800, VL800/T/Z K5/K6 Ignition switch lead wire rerouting procedure

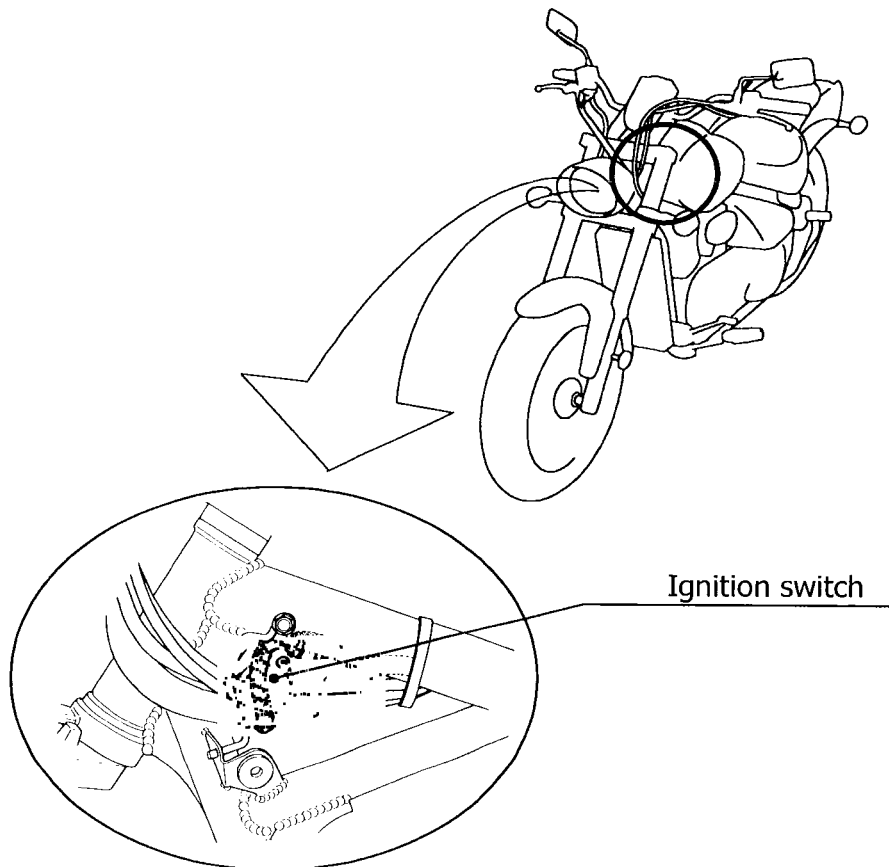
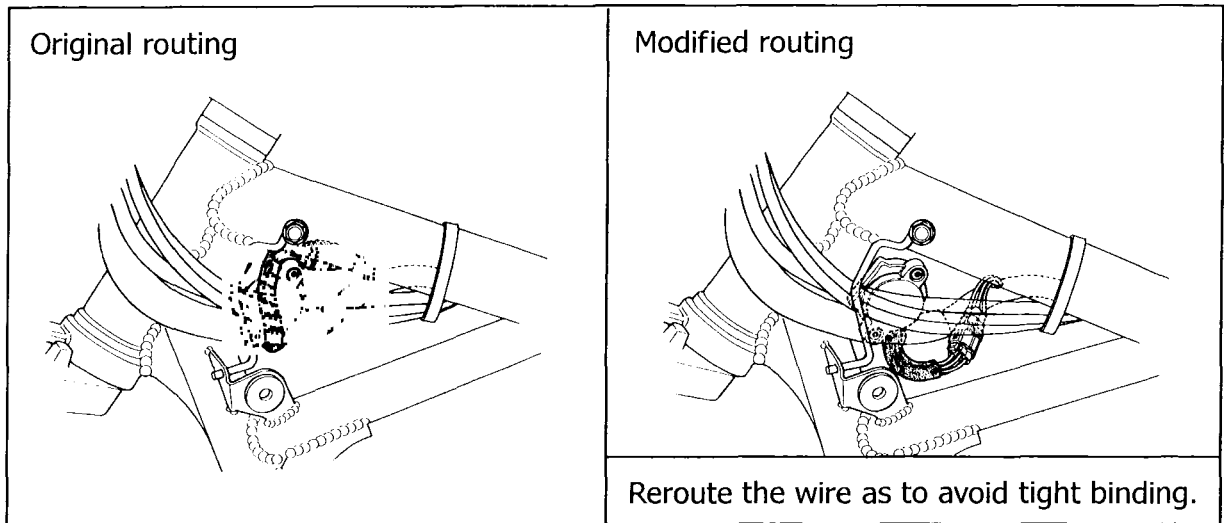
Ignition switch lead wire of these models is routed behind the switch body, with main harness, clutch cable and throttle cable. Due to tight layout on this position, outer cover of lead wire may be rubbed and damaged causing short circuit. When this lead wire short circuit with ignition switch, fuse will be burned causing engine stall due to electric power supply down.

Reroute the lead wire of ignition switch as to avoid tight binding of wires and cables. In the case if lead wire is already damaged, replace ignition switch as LOCK SET with new routing, referring service manual.

You are kindly requested to organize the recall campaign on the affected units in your market. The modification is to be completed by changing the routing of this lead wire. In the case, if outer cover of lead wire is already damage, please replace the ignition switch with new one, with new routing.
