IC Corporation

SAFETY RECALL 05302

Brake Pedal Pivot Bolt Locknut

February 2005

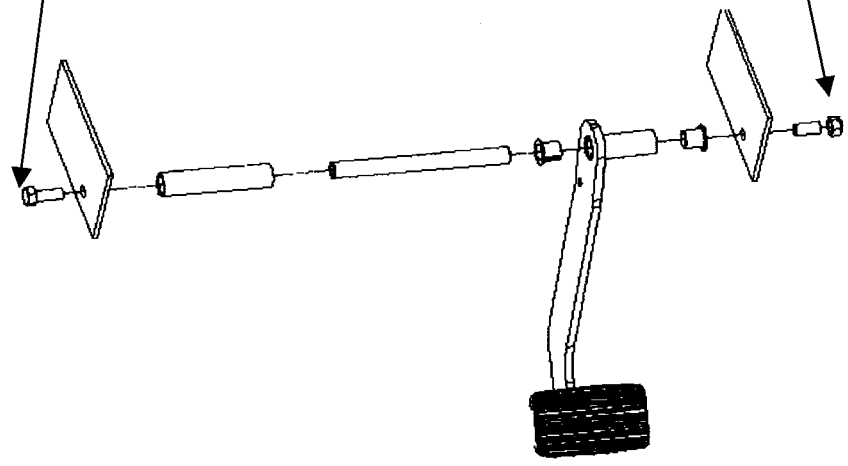
See Figure 3 for a drawing of the complete pivot bracket assembly.
