IC Corporation

05V-131

SAFETY RECALL 05508

Excessive suspension travel may cause the u-joint straps or strap bolts on either end of the driveshaft to fail as a result of the high working angle.

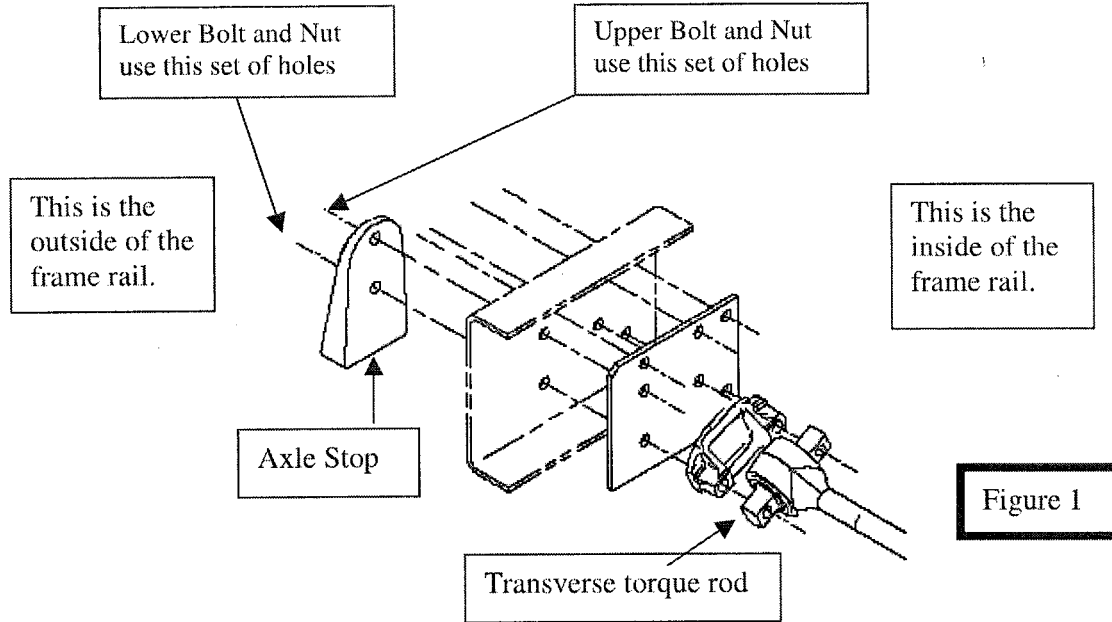
The axle stops are held to the frame rail by 2 sets of bolts and nuts that pass through the frame rail. **Right side** is shown in Figure 1 below. The proper position of the bolts and nuts is to place the bolts into the holes from the inside, so that the nuts are on the outside of the frame rail. This correct position allows sufficient access to the nuts for the torque operation.

1. Remove Upper Nut and Upper Bolt that holds axle stop to frame rail.
2. Remove Lower Nut and Lower Bolt that holds axle stop to frame rail.
3. Replace axle stop with new one.
4. Replace the axle stop bolts and nuts with the **new** bolts and nuts that are included in the kit. Both bolts for the left side are the same length.
5. Torque the axle stop nuts to **between 196 lb-ft and 239 lb-ft**.

1. Remove Upper Nut and Upper Bolt that holds axle stop to frame rail.
2. Remove Lower Nut and Lower Bolt that holds axle stop and transverse torque rod to frame rail.
3. Replace the axle stop bolts and nuts with the **new** bolts and nuts that are included in the kit. Both bolts for the left side are **NOT** the same length. Use the **longer** bolt to replace the Lower Bolt that also holds the transverse torque rod to the frame.
4. Torque the axle stop nuts to **between 196 lb-ft and 239 lb-ft**.
