Recall Campaign

October 2005
FL448A
NHTSA #05V-185

Subject: Accuride 29644 ANP Aluminum Wheels

Work Instructions

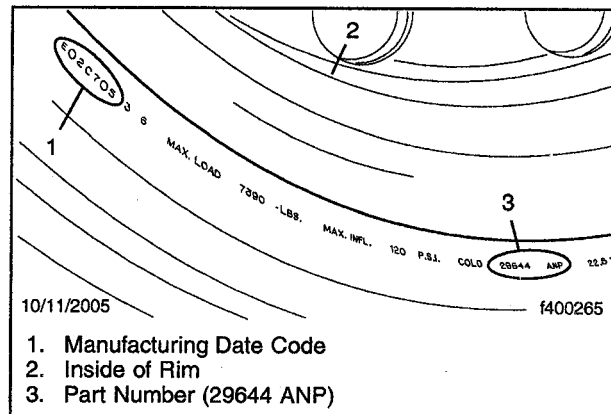
Fig. 1, Wheel Inspection (front wheel shown)

3. Inspect the wheels for the manufacturer's date stamp and part number 29644 ANP. The first six digits of the stamp are the manufacturing date (day, month, year). The manufacturing dates covered by this recall are January 15, 2005, through January 17, 2005 (one of these three date codes: 011505, 011605, or 011705). See **Fig. 1**.

- On the front axle, clean the inboard side of the front wheels and inspect.
 - On tandem rear wheels, the inboard and outboard wheels are mounted back-to-back. To inspect the inboard tandem wheels, use a flashlight to look between the brake drum and the wheel. On the outboard wheels, the date stamp will be on the outside face.

- If the manufacturing date is **not** January 15, 2005, through January 17, 2005 (011505, 011605, or 011705), no further work is needed.

- If the manufacturing date is January 15, 2005, through January 17, 2005 (011505, 011605, or 011705), replace the wheel, following the procedures below.
4. Remove the disc wheel.
 - 4.1 If working on the front axle wheels, raise the front of the vehicle until the tires clear the floor. Place safety stands under the front axle.

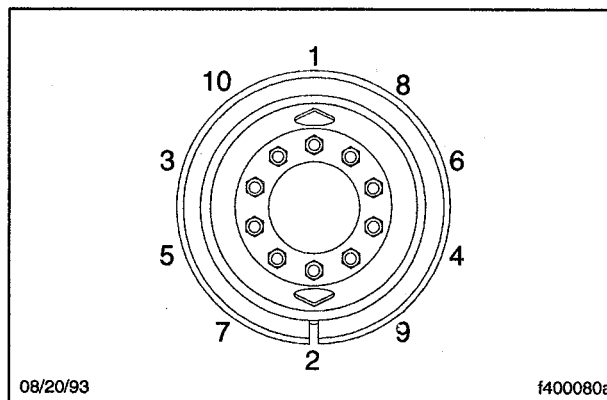
Fig. 8, 10-Stud Disc Wheel Tightening Sequence

Too little wheel nut torque can cause wheel shimmy, wheel damage, stud breakage, and extreme tire tread wear. Too much wheel nut torque can break studs, damage threads, and crack discs in the stud hole area. Use the specified torque values, and follow the tightening sequence in Fig. 8.

- 7.6 Install and hand-tighten the remaining two-piece flange nuts. Tighten the nuts 50 lbf-ft (68 N·m) following the sequence in Fig. 8.
- 7.7 Check that the wheel is correctly seated against the hub and on the hub-pilot pads.
- 7.8 Following the sequence in Fig. 8, tighten the two-piece flange nuts 450 to 500 lbf-ft (610 to 678 N·m).

- 7.10 After operating the vehicle for 50 to 100 miles (80 to 160 km), retighten the wheel nuts 450 to 500 lbf·ft (610 to 678 N·m). Follow the sequence in **Fig. 8**.
8. Clean a spot on the base label (Form WAR259). The base label is usually located on the passenger-side door about 12 inches (30 cm) below the door latch. Write the campaign number, FL448, on the blank completion sticker (Form WAR260) from the recall kit, and attach it to the base label.
9. Close the hood and remove the chocks from the tires.
