# Recall Campaign

February 2006  
FL464B  
NHTSA #05V-541

### Subject: Fontaine Modification Sit Down, Dual Drive Bolts

Freightliner LLC, on behalf of its Freightliner Trucks Division, has decided that a defect which relates to motor vehicle safety exists on specific Freightliner Business Class M2 vehicles manufactured between August 2004 and October 2005 with a right-hand drive position added by Fontaine Modification.

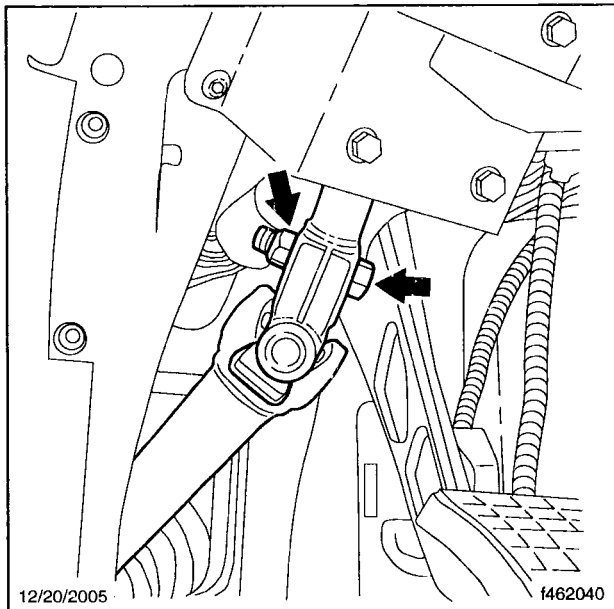
**Fig. 3, Pinch Bolt on Intermediate Shaft, Left-Hand Side**

The left-hand steering U-joint pinch bolt that secures the lower steering shaft to the left-hand miter box may have been improperly tightened. Incorrect hardware may have been used to install the steering cross shaft. Loss of a steering shaft pinch bolt or of a cross shaft fastener may cause a loss of steering control and possible vehicle crash without prior warning.

2. Locate the steering pinch bolt that connects the intermediate shaft to the 3-way gear box. See **Fig. 3**. Remove the steering pinch bolt and nut then discard them.

3. Install the pinch bolt and prevailing torque nut from the kit. Tighten the nut to 30 to 35 lbf-ft (40 to 45 N·m).
4. Locate the two through bolts on the steering cross-shaft U-joint, that connects the 3-way gear box on the left side, to the cross shaft. See **Fig. 4**. Remove both of the through bolts, and replace them with two 3/8-inch x 2.25-inch bolts and 3/8-inch stover nuts from the kit. Tighten the nuts to 30 to 35 lbf-ft (40 to 45 N·m).
5. Install the left-hand steering column covers.

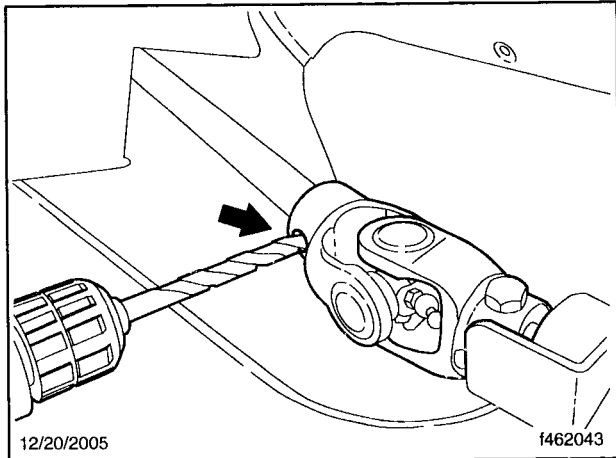
**Fig. 6, Cross Shaft with One Through Bolt, Right-Hand Side**

- 3.1 If one through bolt is observed:

Remove the through bolt and replace it with a 3/8-inch x 2.25-inch bolt and 3/8-inch stover nut from the kit. Tighten the nut to 30 to 35 lbf-ft (40 to 45 N·m).

Locate the setscrew in the cross-shaft U-joint yoke (in some cases the setscrew is positioned 90 degrees from the keyway position). Remove the setscrew, then using the hole as a drill guide, carefully drill a 3/8-inch hole through the cross shaft. See **Fig. 6**.

Install the supplied 3/8-inch x 2.25-inch bolt, and 3/8-inch stover nut. Tighten the nut to 30 to 35 lbf-ft (40 to 45 N·m).

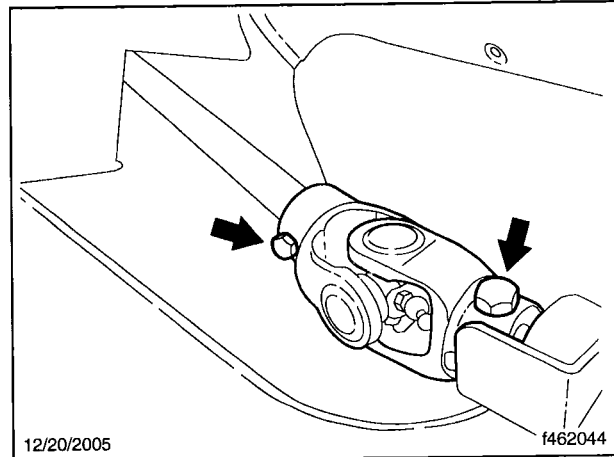
**Fig. 7, Cross Shaft With Two Through Bolts, Right-Hand Side**

3.2 If two through bolts are observed:

Remove the through bolts and replace them with two 3/8-inch x 2.25-inch bolts and 3/8-inch stover nuts from the kit. Tighten the nuts to 30 to 35 lbf-ft (40 to 45 N·m). See **Fig. 7**.
