Recall Campaign

February 2006
FL466AB
NHTSA #05V-550

Copy of Letter to Owner Subject: Visteon Windshield Wiper Motors

Windshield Wiper Motor Inspection and Replacement Procedure

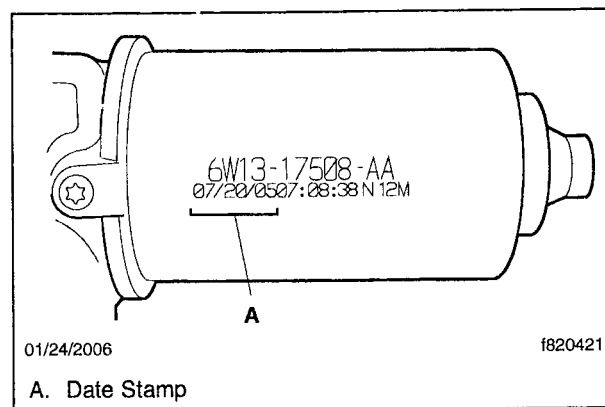
Fig. 1, Wiper Motor

1. Check the base label (Form WAR259) for a completion sticker for FL466 (Form WAR260) indicating this work has been done. The base label is usually located on the passenger-side door about 12 inches (30 cm) below the door latch. If a completion sticker is present, no further work is needed. If there is no completion sticker, go to the next step.
2. Park the vehicle on a level surface, shut down the engine, and set the parking brake. Chock the tires.
3. Open the hood.
4. Clean the wiper-motor housing and inspect the date stamp. See **Fig. 1**

NOTE: The date is written on the housing in light grey ink.

5. If the date is before September 1, 2005, or after October 14, 2005, no further work is necessary. Close the hood and go to step 16.

If the date falls between September 1, 2005, and October 14, 2005, replace the wiper motor using the following instructions.
