Re: Defect Information Report (FL-467), NHTSA 05V-551

Section 573.6 Non-Compliance Information Report
FL-467, Front Axle I-Beam; NHTSA no. 05V-551
Supplement No.: 3

Subject: AAC Front Axle I-Beams

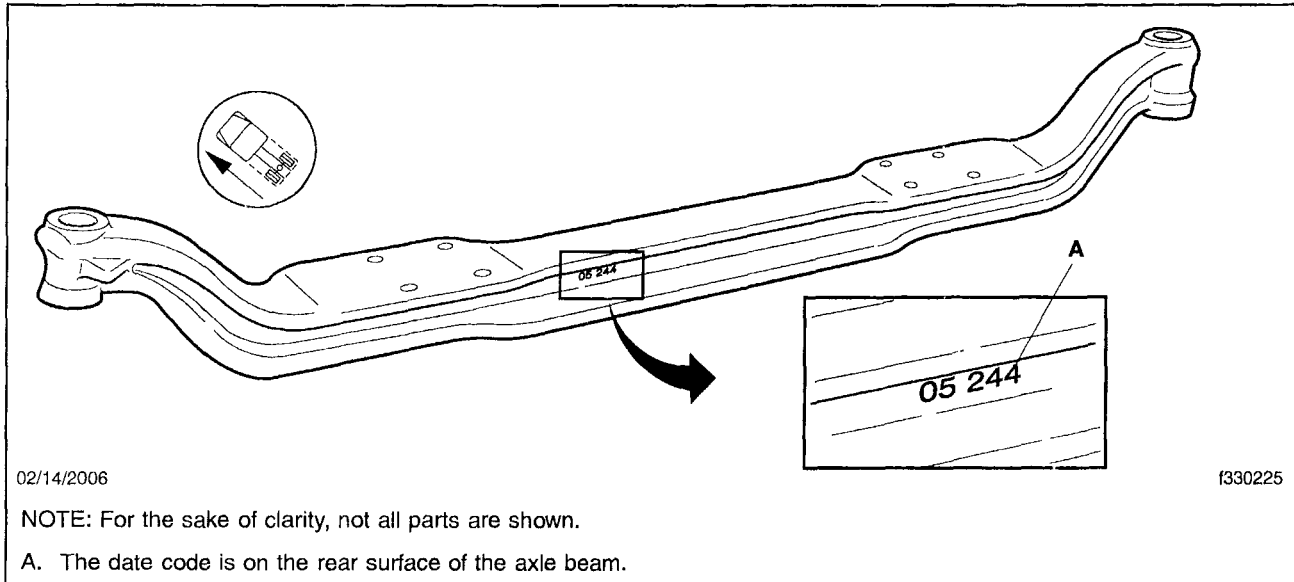
Fig. 1, Location of Date Code on Front-Axle Beam

A forging defect in the top flange of certain front axle I-beams may cause fatigue and fracture, resulting in a possible loss of control and vehicle crash without prior warning.

1. Check the base label (Form WAR259) for a completion sticker for FL467 indicating this work has been done. On straight trucks and tractors, the base label is usually located on the passenger-side door about 12 inches (30 cm) below the door latch; on motorhomes, the base label is usually located on the front wall under the dash. If a sticker for FL467 is present, nothing further needs to be done. If no sticker is present, go to the next step.
2. Park the vehicle on a level surface, shut down the engine, set the parking brake, and chock the rear tires.
3. Find the date code on the rear surface of the axle I-beam web, on the driver's side and near the U-bolt pad. See **Fig. 1**. Affected axle beams are those with the date code *05 244*.

If the date code is NOT *05 244*, no further work is necessary. Clean a spot on the base label (Form WAR259). Write the recall number, FL467, on a blank red completion sticker (Form WAR260) and attach it to the base label.

If the date code IS *05 244*, go to the next step.
