OSV-336

Subject: Defect Information Report relating to certain model stop arms shipped to U.S. Bus Corporation between January 1, 2002 and March 1, 2005.

NHTSA Campaign Number: 05E-032

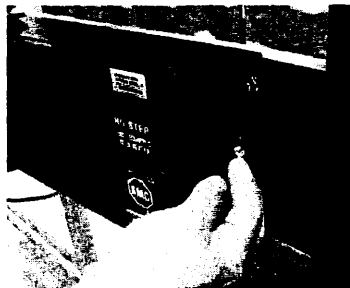
15. Heater inspection and electrical connection-
In order for the new switches to operate properly, the heater must be wired to a 12v source that is controlled by the ignition switch. Inspect bus heater wiring to verify. If heater is not connected to the ignition circuit, there are two possible wiring configurations to achieve this:

LEAVE THIS
SECTION
UNSEALED

- a) on full size buses, route the yellow wire from the heater into the electrical access panel located just in front of the stop arm. In this panel connect the heater to a switched electrical circuit such as "IGNITION ASSY"
- b) On "cutaway" buses, use the snap connector included with the switch kit to connect the yellow wire from the heater to the double red wire in the stop arm. After doing this, the red wire (12v+) coming into the stop must be reconnected to a switched ignition source.

16. Replace cover. Secure with (2) screws. Reseal both ends of the crossing arm cover with RTV. **IMPORTANT! - DO NOT seal approximately 1" of the lower right side of the box. This provides an additional drainage location.**
