RE: RECALL CAMPAIGN – REPLACEMENT OF OUTLET HOSE CONTAINED IN FUEL PUMP NOISE REDUCTION KIT PF59918PB – RE05/01

05-01-31-01

Title: Recall Campaign - Replacement of Outlet Hose Contained In Fuel Pump Noise Reduction Kit PF59918PB - RE 05/01

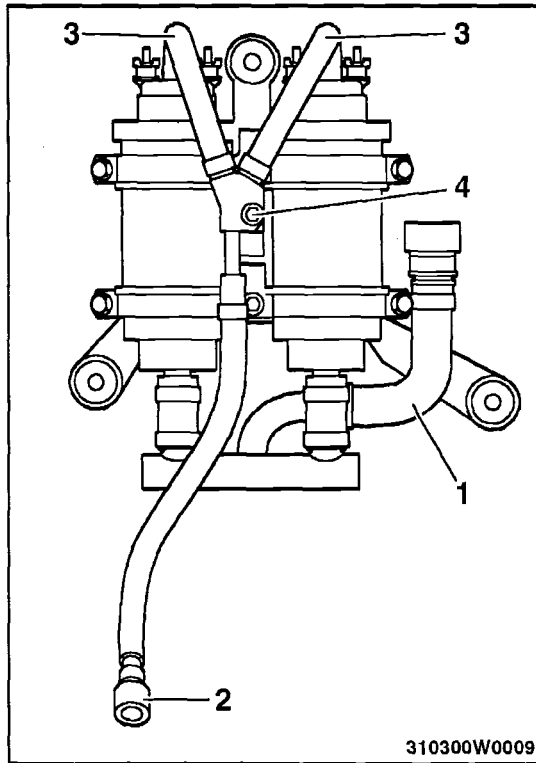
Figure 1

1. Position the vehicle on a ramp, remove gearbox isolation fuse.
Refer to ASSIST PIN 5936
2. Allow the exhaust system to cool (approximately 30 minutes) prior to opening up the fuel system
3. Make a note of owners preferred radio memories
4. Disconnect the negative leads of both batteries. Refer to ASSIST PIN 5903
5. Remove left-hand rear undersheet to gain access to the fuel filter inlet pipe nut
6. To release fuel pressure, slowly undo fuel filter inlet pipe nut whilst holding a cloth over the connection to catch any escaping fuel.
Retighten nut.
7. Attach a clamp to the outlet hose from the fuel tank, see figure 1 item 1
8. Prepare the quick connector item 2 figure 1 for disconnection

11. Use pliers part number PF 29155PA to release hose clips then disconnect both fuel pump outlet hoses, items 3 in figure 1
12. Remove the 5mm bolt securing the fuel pump outlet hose assembly to the fuel pump bracket (item 4 figure 1), remove and discard the fuel pump outlet hose assembly

13. Position the new fuel pump outlet hose assembly (part number PF 59918PC) over the fuel pumps and secure with 5mm bolt removed during operation 12
14. Position one Oetiker hose clip (part number N10023201) onto each fuel pump outlet hose before pushing each hose onto the fuel pump outlet ports see figure 1 items 3
15. With the clips positioned use Oetiker side jaw pincers (part number WT10001). Hold the pliers parallel to the hose and close the clip ear fully. It is important that a constant pressure is applied to close the clip ear. This method ensures positive stress on the hose, which does not result in excessive compression or expansion of the clip material. The clip will not always remain closed fully and a permitted opening after closure is shown in figure 4
16. Prepare the quick connector item 2 figure 1 for reconnection

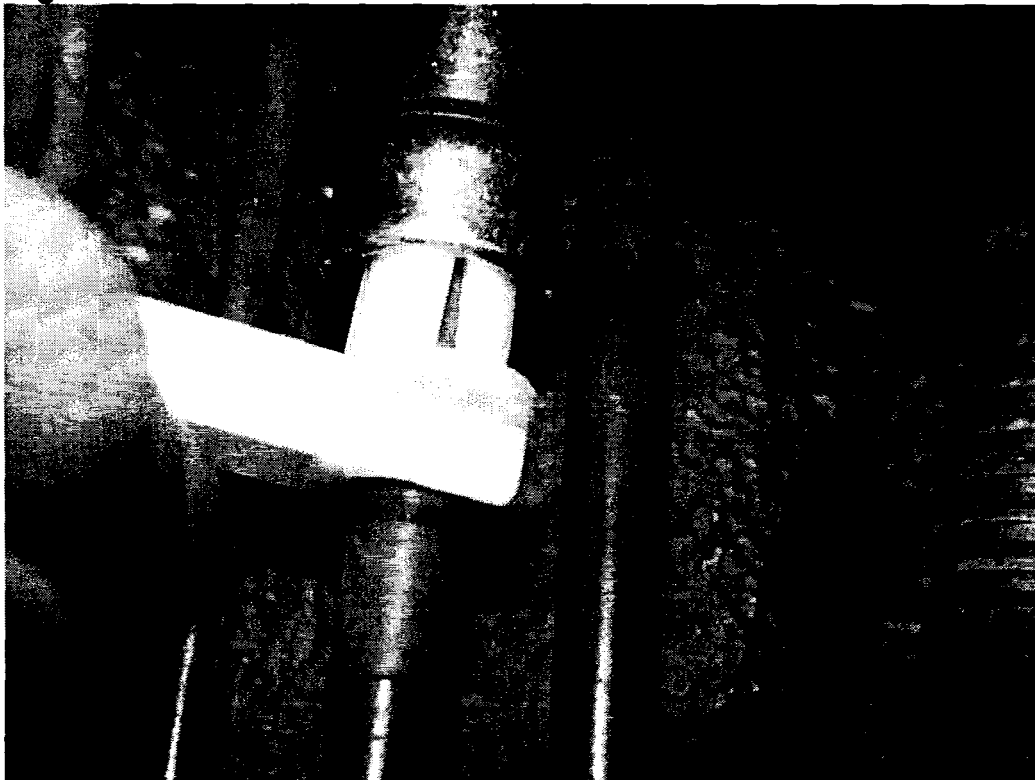
Figure 2

Note: If the quick connector has previously had the release collar removed, then the secondary safety clip will have to be removed before pushing tool WT10091 into the quick connector and simultaneously pulling the hose from the pipe fitting Refer to figure 2

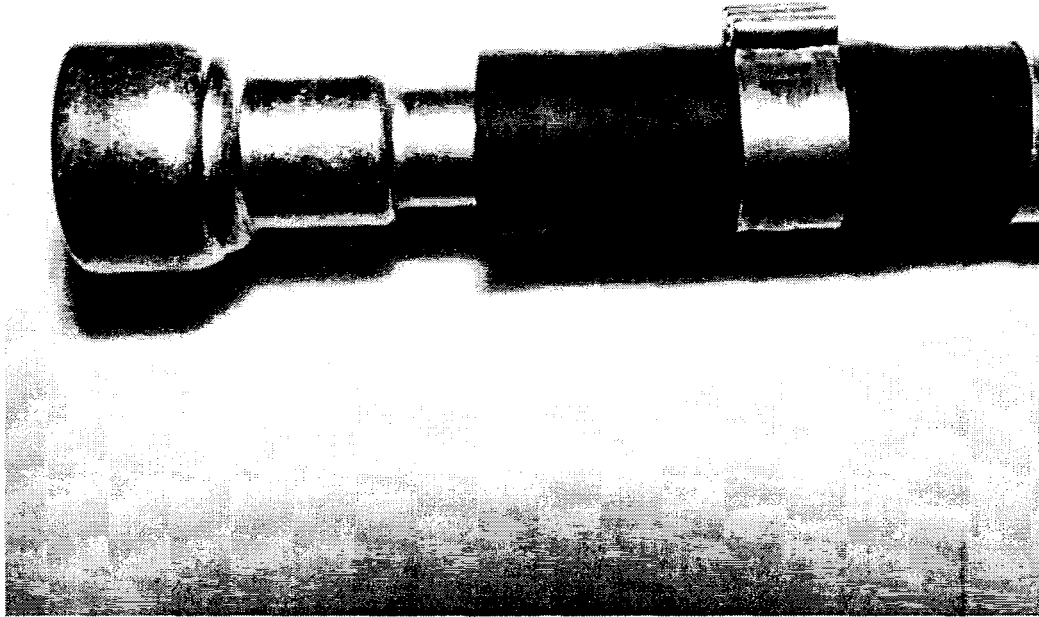
Figure 3

Note The Cobra clip position, at the extreme edge of the quick connector fitting (see figure 3), is a design requirement of the fitting, do not therefore reject the new hose (part number PF 59918PC) for this reason

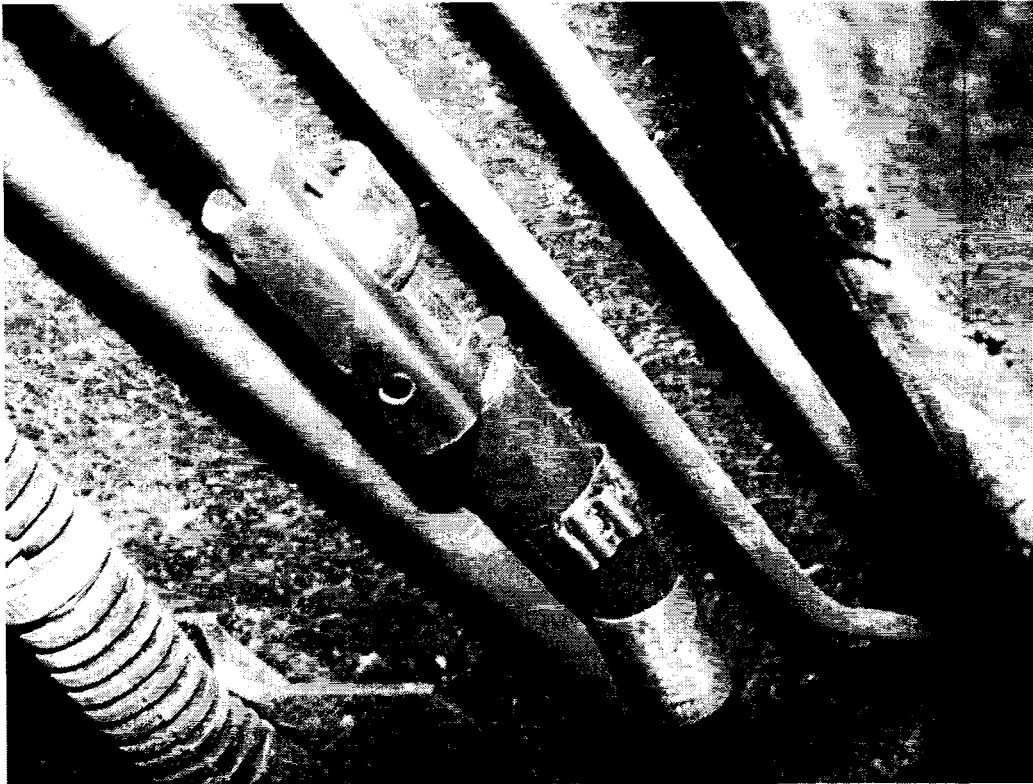
Figure 5

22. Fit a secondary latch safety clip, part number PF113200PA, to the quick connector. Refer to figure 5
23. Remove clamp from outlet hose of fuel tank
24. Carry out an initial inspection of replacement hose assembly for leaks, rectify any leaks before proceeding with bulletin
25. Reconnect battery earth leads
26. Observe the relevant workshop safety procedures. Refer to ASSIST PIN 0039. Turn on the ignition and allow at least 5 seconds for the fuel system to pressurise, then check all fuel pipe connectors worked on in this bulletin for leaks
27. Start the engine and once again check pipe connections for leaks and if necessary rectify
28. Refit the left-hand rear undersheet
29. Reset radio presets and initialize electric window lifts. Refer to ASSIST PIN 5903
30. Affix completion label (part number PS 115553PA). See figure 6
31. Refit gearbox isolation fuse
