**Re: Defect Information Report (FL-438), NHTSA no. 05V-001  
Gra-Mag Seats**

**Section 573.6 Defect Information Report**  
**FL-438, NHTSA no. 05V-001**  
**Supplement No.: 1**

## Subject: GRA-MAG Seat Pivot Bolts

April 2005  
FL438A  
NHTSA # 05V-001

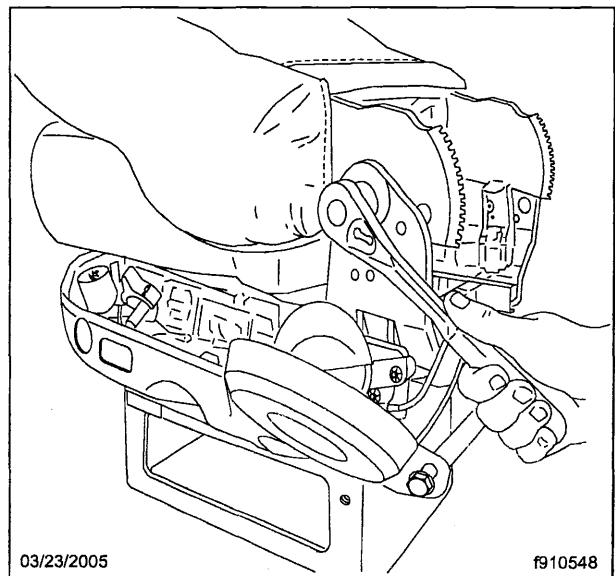
**Fig. 14, Remove One Pivot Bolt at a Time**

The seat pivot bolts may become loose, fracture or dislodge which may allow the seat back to fail to provide full support to the driver. A possible vehicle crash without prior warning could result should the seat fall backwards during vehicle operation.

16. Tilt the seat back all the way forward. Using the correct size socket, remove one pivot bolt. See Fig. 14.
17. Using Loctite<sup>®</sup> ODC-Free Cleaner & Degreaser, thoroughly clean the threads on the bolt that was removed and the threads on the seat back frame. It is very important to have a clean, dry surface in order for the Loctite<sup>®</sup> to work properly.

18. After the threads on the pivot bolts and seat back frame have been thoroughly cleaned and wiped dry, apply Loctite<sup>®</sup> 262 to the threads of the pivot bolt only. Be sure to cover the entire thread surface with Loctite. Do not use any other type of threadlock.

19. Insert the pivot bolt into the frame by hand and tighten it until it seats. Once seated, torque the M12 bolt 30 to 32 lbf-ft (40 to 44 N-m); torque the M14 bolt 37 to 41 lbf-ft (50 to 55 N-m).
