NUMBER  
042

MODEL  
Sedona

DATE  
March 2005

RECALL CAMPAIGN: THROTTLE CABLE ASSEMBLY REPLACEMENT

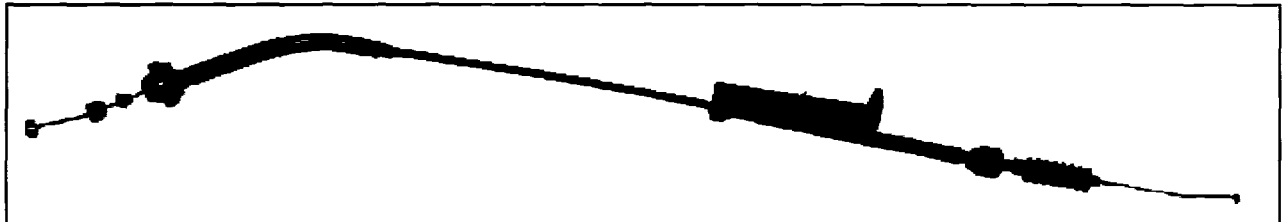
Guide Clip

**Only** Sedona vehicles produced from 3/20/01 through 11/7/01 will at the same time have a guide clip installed on the throttle body assembly in order to ensure that the new cable does not move out of position. Vehicles manufactured beginning on 11/8/01 already have an extended guide on the bell crank which keeps the cable in position.
