Frank M. Ligon  
Director  
Service Engineering Operations  
Ford Customer Service Division

March 4, 2005

**SUBJECT:** Safety Recall 05S28 - Supplement #2  
Certain 2000 Model Year F-150, Expedition, Navigator, and 2001 F-150 SuperCrew  
Vehicles Equipped With Speed Control  
Speed Control Deactivation Switch Replacement

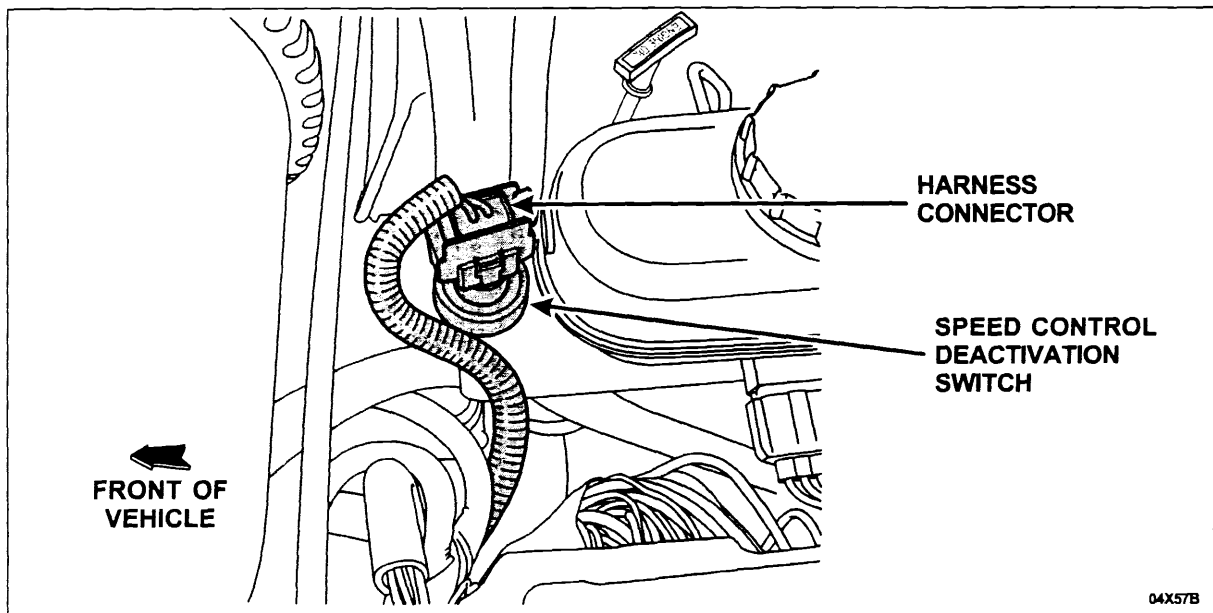
**FIGURE 2**

- If no brake fluid is present, proceed to Labor Operation B – Repair for a Non-Leaking Switch.
  - If brake fluid is present, disconnect the Speed Control Servo and inspect the vehicle harness connector for heat damage.

- If no heat damage is found (even if there is presence of brake fluid in the connector), proceed to Labor Operation C – Repair for a Leaking Switch.

- If the connector is heat damaged, call the Special Service Support Center at 1-800-325-5621 for further instructions.
