Ford Motor Company  
P. O. Box 1904  
Dearborn, Michigan 48121

January 28, 2008

**SUBJECT:** **Safety Recall 05S28 - Supplement #14:** 1992-2004 Multiple Vehicle Lines - Speed Control System Modification

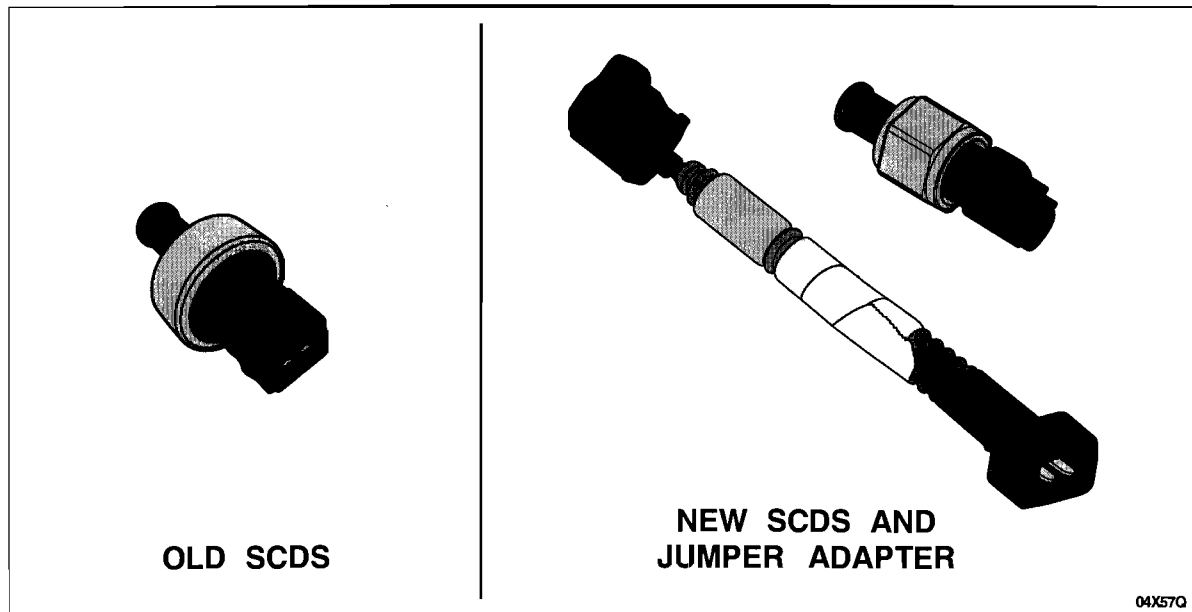
**FIGURE 1**

The Speed Control Deactivation Switch (SCDS) involved in Recall 05S28 and the revised SCDS is illustrated below. See Figure 1.

Note that the revised SCDS has a different electrical connector. A jumper adapter (which is included in the parts kit) is required when replacing the old SCDS with the revised SCDS.

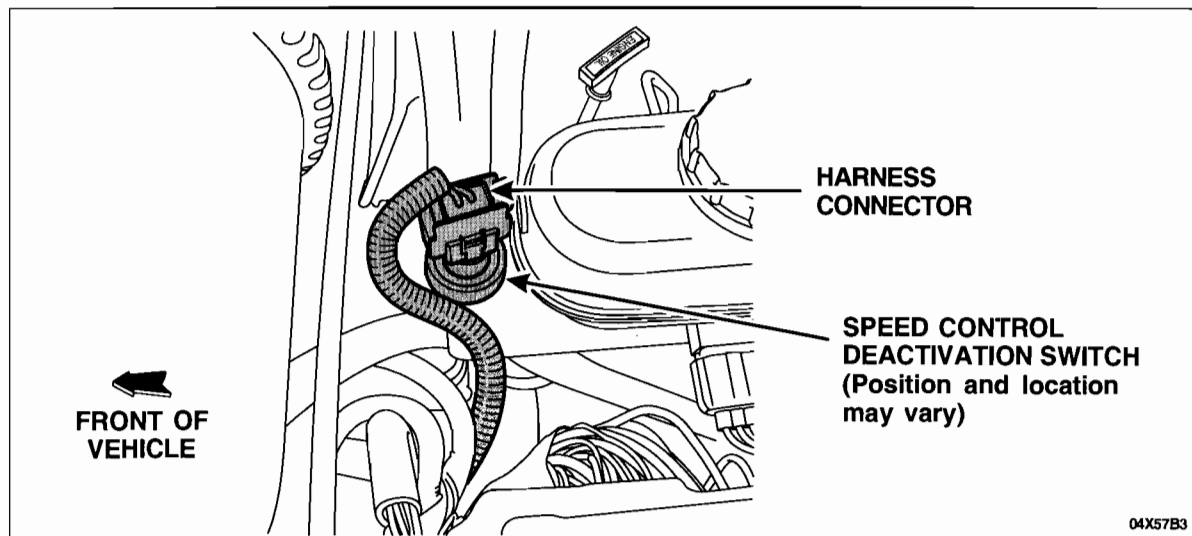
FIGURE 2

Disconnect the SCDS and inspect the harness connector (see Figure 2) for the presence of brake fluid.  
Refer to the Vehicle Application And Repair Chart on page 5 to identify the correct repair procedure.
