GM SERVICE AND PARTS OPERATIONS  
DCS1328  
URGENT - DISTRIBUTE IMMEDIATELY

Date: January 24, 2005  
Subject: 05010A - Product Safety Recall  
Intermediate Steering Shaft to Steering Gear Bolt  
Models: 2005 Chevrolet Silverado  
2005 GMC Sierra  
To: All Chevrolet and GMC Dealers  
Attention: Service Manager, Parts Manager and Warranty Administrator

File In Section: Product Recalls  
Bulletin No.: 05010A  
Date: January 2005

**SUBJECT: INTERMEDIATE STEERING SHAFT TO STEERING GEAR BOLT**

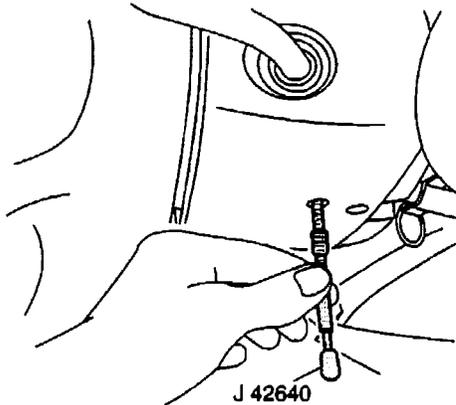
333146

General Motors has decided that a defect, which relates to motor vehicle safety, exists in **certain** 2005 Chevrolet Silverado and GMC Sierra vehicles. The bolt that attaches the intermediate steering shaft to the steering gear may not meet specification. The bolt may fracture, resulting in the loss of steering. If this happens while the vehicle is moving, a crash could occur without prior warning.

2. Install J 42640 in the steering column lower access hole.
3. For vehicles equipped with a 6.6L diesel engine, remove the left charge air cooler hose.
4. Remove the bolt from the lower shaft coupler.
5. Install the new bolt to the lower shaft coupler. **Tighten**

Tighten the coupler pinch bolt to 47 N·m (35 lb ft).
