# **VEHICLE RECALL**

G-05504  
April 2005

**SUBJECT: SAFETY RECALL (U.S., EXPORT)  
Brake Pedal Pivot Bolt Locknut on certain CE school  
bus models built between 4/27/2004 and 10/13/2004**

**SUBJECT: SAFETY RECALL (U.S., EXPORT)  
TURN SIGNAL SWITCH assemblies on certain 3300,  
4200, 4300, 4400, and CE School Bus models built  
5/24/2004 thru 8/17/2004**

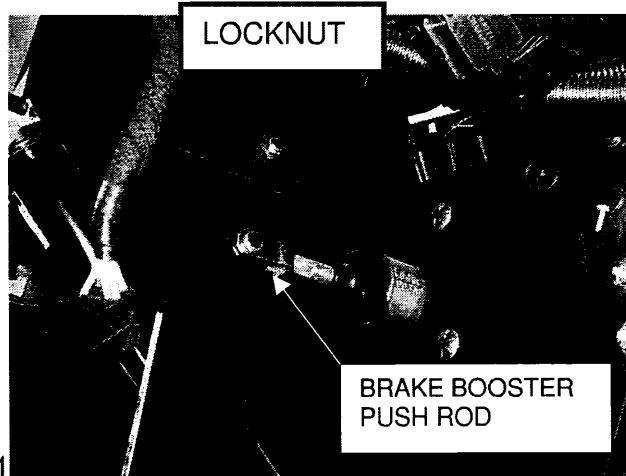
An incorrectly torqued locknut on the brake pedal pivot bracket can allow the pivot bolt to back out of the bracket. This may result in the brake pedal falling off.

*See Figure 1 for location of locknut in a bus.*

1. Inspect the locknut. The locknut is located on the right hand side of the pivot bracket, above the brake pedal. **Do not confuse this locknut with the nut on the brake booster push rod below it.** See Figure 1.
2. If the locknut appears to be tight, check the torque.  
Proper torque for this locknut is 75 to 85 ft-lb.
3. If the locknut is torqued above or below this range, proceed to step #4.  
If the torque is within this range, no further action is necessary.
4. Remove the locknut. Care must be taken to not allow the pivot bolt to back out or the bushings to fall out of the assembly. See figure 3.
5. Inspect the locknut for damage.  
If the locknut is not damaged, continue.  
If the locknut is damaged, Replace the locknut and continue.
6. Place the locknut onto the pivot bolt.
7. Tighten locknut to 75 to 85 ft-lb of torque with a torque spec tool.

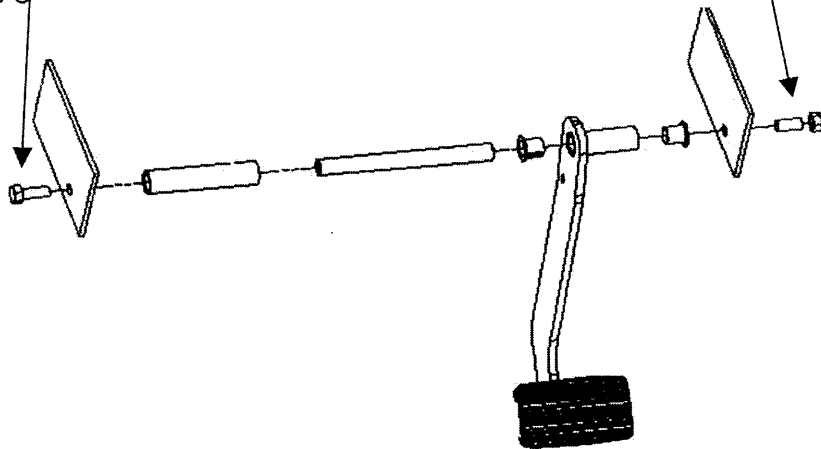
*See Figure 3 for a drawing of the complete assembly.*

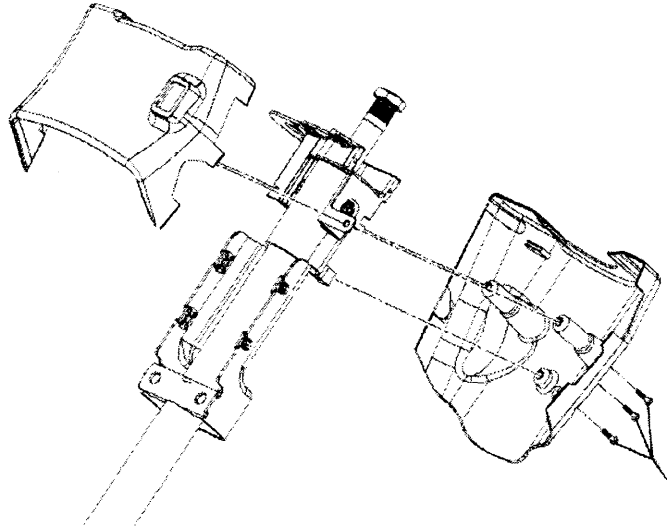
**Figure 1**

1. Remove the three (3) screws that fasten the lower steering column trim to the steering column.

7. Install new switch assembly and connect electrical connector. See **Figure 4**.
  - a. If the vehicle has a Blue Bird body, use **2589451C91**.
  - b. For all other vehicles and bus bodies, use **3587009C91**.
8. Perform functional test on switch to verify all turn signals and hazard lamps function.
9. Re-install upper and lower steering column trim panels. See **Figure 1**.

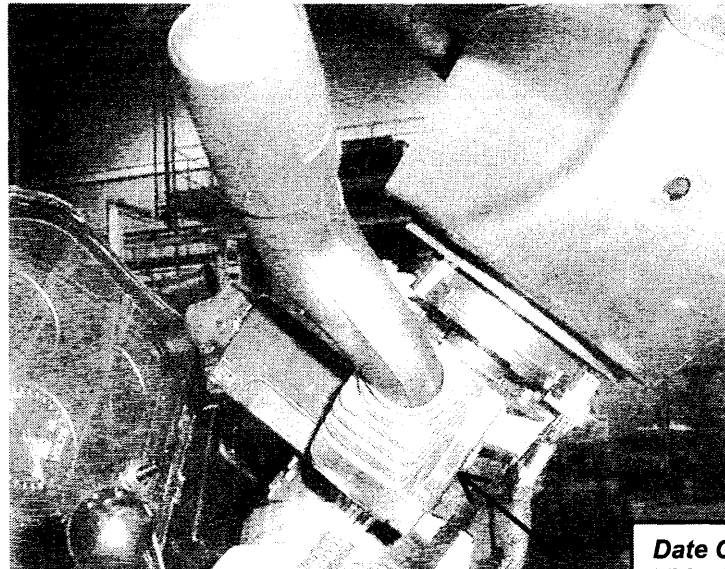
**Figure 2**

2. Inspect the underside of the turn signal stalk assembly for the build date code.

*Date Code in  
This Area*

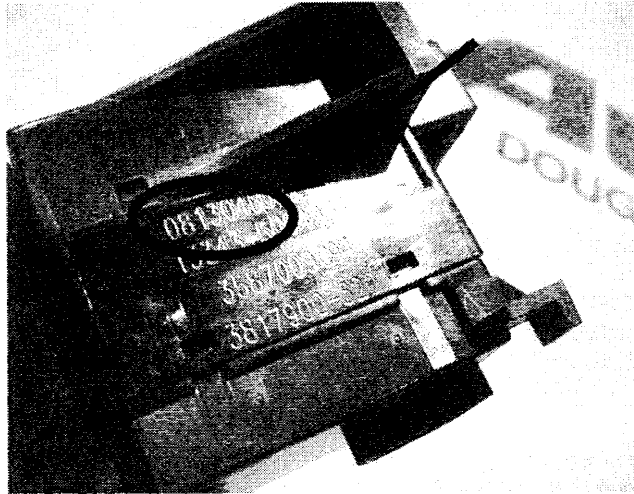
Figure 3

**NOTE:** The example in Figure 3, 081304, corresponds to a build date of August 13<sup>th</sup> of 2004.

3. Replacement of the turn signal switch is required if the switch build date codes are between **051504** (May 15, 2004) thru **062804** (June 28, 2004). If the build date is within this range, skip to step 5.
4. If the date code on the switch assembly is **NOT** in the range listed in step 3, **NO FURTHER ACTION IS NECESSARY**, re-install lower column trim panel and fasteners.

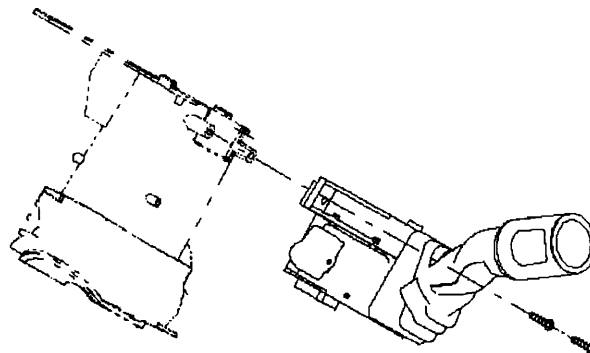
Figure 4

5. Remove the upper column trim panel.
6. Disconnect electrical connector and remove switch assembly.
