TOYOTA CUSTOMER SERVICES

Volume: XII
Number: TC05-003
Date: 02/18/2005
 Action
 Retain
 Information

SUBJECT: SPECIAL SERVICE CAMPAIGN (SSC) – 50C
(2005 MODEL YEAR TACOMA PARKING BRAKE PEDAL CABLE LOCK NUT)

TECHNICAL INSTRUCTIONS

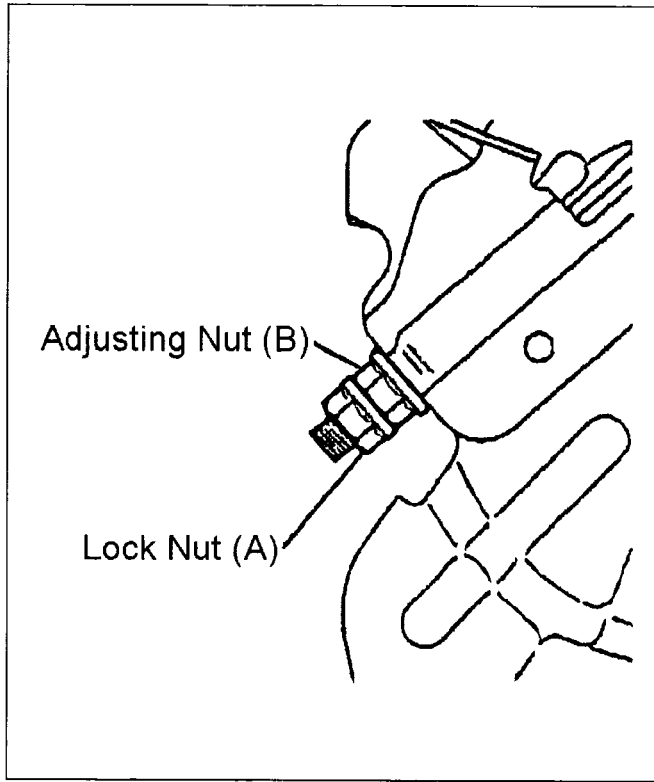
1. INSPECT THE PARKING BRAKE PEDAL CABLE LOCK NUT AND ADJUSTING NUT

- Check that the parking brake pedal cable lock nut A and adjusting nut B are still fastened. If the nut(s) are missing install a new one.

Use the following Part Numbers (P/N) to order the lock nut and adjusting nut, ONLY if they are missing.

Lock Nut P/N: 90179-06299

Adjusting Nut P/N: 90179-06074

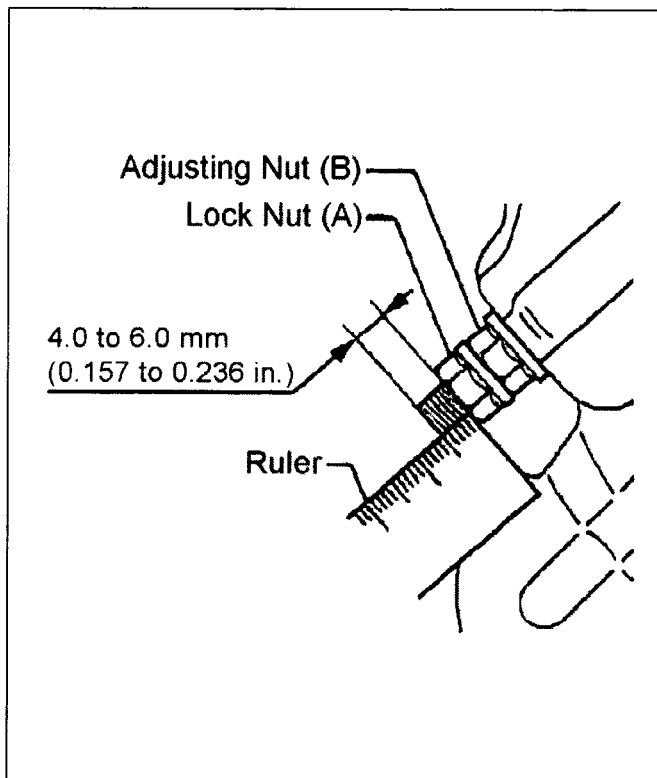
2. MEASURE THE REMAINING THREAD LENGTH OF THE PARKING BRAKE PEDAL CABLE

- Using a ruler, measure the remaining thread length of the parking brake pedal cable from lock nut A. The remaining thread length should be between 4 and 6 mm (0.157 to 0.236 in.).
- If it is not within specification, then loosen the parking brake pedal cable lock nut A and turn adjusting nut B using the special tool or an open-end wrench with a thickness of less than 3.5 mm (0.138 in.) until the remaining thread length is within specification.

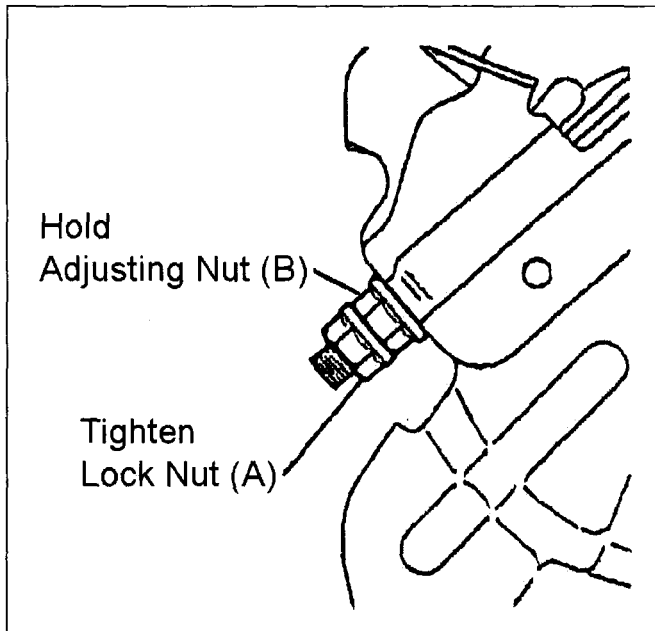
3. TIGHTEN THE PARKING BRAKE PEDAL CABLE LOCK NUT

- (a) Hold the parking brake pedal cable adjusting nut B using the special tool or an open-end wrench with a thickness of less than 3.5 mm (0.138 in.), then tighten lock nut A to proper torque specification.

Torque:

5.4 N·m (55 kgf·cm, 48 in·lb)
