Subject: 05015 Safety Recall
 Seat Latch Release Lever Actuation

Models: 2005 Chevrolet Uplander
 2005 Pontiac Montana SV6
 Equipped with Second Row Bucket Seats (AL4)

Recall Bulletin

SUBJECT: SEAT LATCH RELEASE LEVER ACTUATION

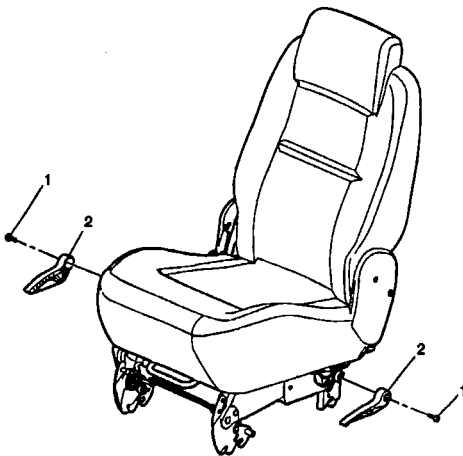
1546920

General Motors has decided that a defect, which relates to motor vehicle safety, exists in **certain** 2005 model year Chevrolet Uplander and Pontiac Montana SV6 vans. In a severe side impact test, a part of the vehicle deformed and actuated the outboard release handle of a second-row bucket seat and the rear latches became unlatched early during the crash sequence. If the rear latches of the seat are released early in a severe side impact crash, the potential for injury to the occupant of the seat is increased.

Dealers are to remove the seat latch release handle and install a black plastic cap over the exposed metal stud to eliminate the side impact safety concern. Please note that even though the handle is not being replaced, seat functionality is not diminished as the primary release strap remains at the rear of the seat

1. Remove the rear seat latch handle screw (1).
2. Remove the rear seat latch handle (2) from the rear seat.
3. Install a new cap over the end of the rod.
4. Repeat steps for the rear seat on the other side of the vehicle, if applicable.
