Date: March 4, 2005
To: All Dealers and Employees
From: MMNA Public Relations
RE: Parking Brake Lock-nut Recall

SUBJECT:		PARKING BRAKE CABLE LOCK NUTS — SAFETY RECALL CAMPAIGN		No:	SR-05-001
				DATE:	March, 2005
				MODEL:	2004-05 Endeavor
CIRCULATE TO:	<input checked="" type="checkbox"/> GENERAL MANAGER	<input checked="" type="checkbox"/> PARTS MANAGER	<input checked="" type="checkbox"/> TECHNICIAN		
<input checked="" type="checkbox"/> SERVICE ADVISOR	<input checked="" type="checkbox"/> SERVICE MANAGER	<input checked="" type="checkbox"/> WARRANTY PROCESSOR	<input checked="" type="checkbox"/> SALES MANAGER

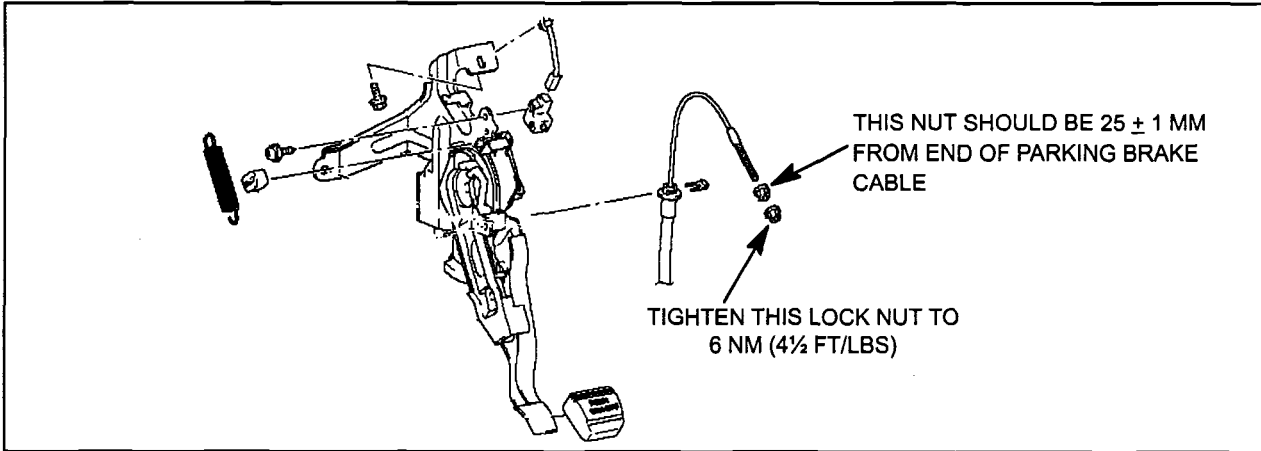
The parking brake cable lock nuts on some affected vehicles may not have been tightened to the proper torque specification. If not tightened properly, the nuts may loosen and come off, reducing the effectiveness of the parking brake. This condition could allow the vehicle to roll if the transmission is not in "Park" and the vehicle is parked on a slope, increasing the possibility of a crash.

1. Release the parking brake.
2. Be sure the first parking brake cable lock nut is positioned 25 ± 1 mm from the end of the parking brake cable.
3. Torque the second lock nut to 6 Nm ($4\frac{1}{2}$ ft/lbs) against the first nut.

NOTE: If a lock nut is missing, install a new lock nut, listed in the PARTS INFORMATION section of this bulletin. Torque the new lock nut to 6 Nm ($4\frac{1}{2}$ ft/lbs).

4. Confirm proper parking brake operation.
