# BMW Motorrad USA

## Service Information Bulletin

**Subject:** Recall 05V-082: Seal for fuel pump electronics.

**Model:** R 1200 GS

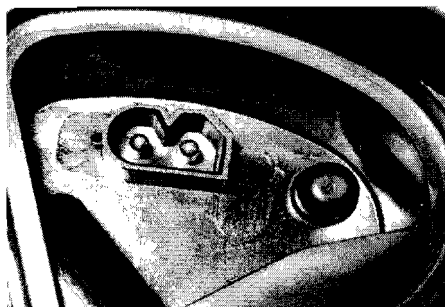
Contacts **without** corrosion

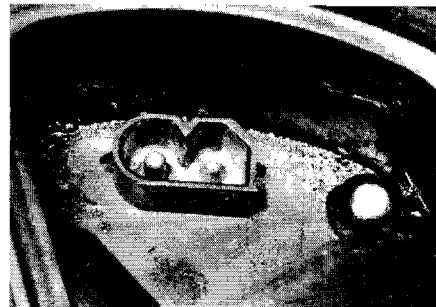
Check the contacts of the black plug at the base of the fuel pump unit. The fuel pump unit must be replaced if there are clear signs of corrosion at the contacts. Refer to the two pictures below for details on the location and appearance of corrosion in this area.

Contacts **with** corrosion

Remove all traces of water and/or moisture inside the cavity and on the connecting plugs.
