PREVOST

**SAFETY
RECALL**

Sr05-06

DATE : May-2005	SECTION : 16
SUBJECT : IMPROPER MOUNTING OF 3 RADIUS ROD SUPPORTS

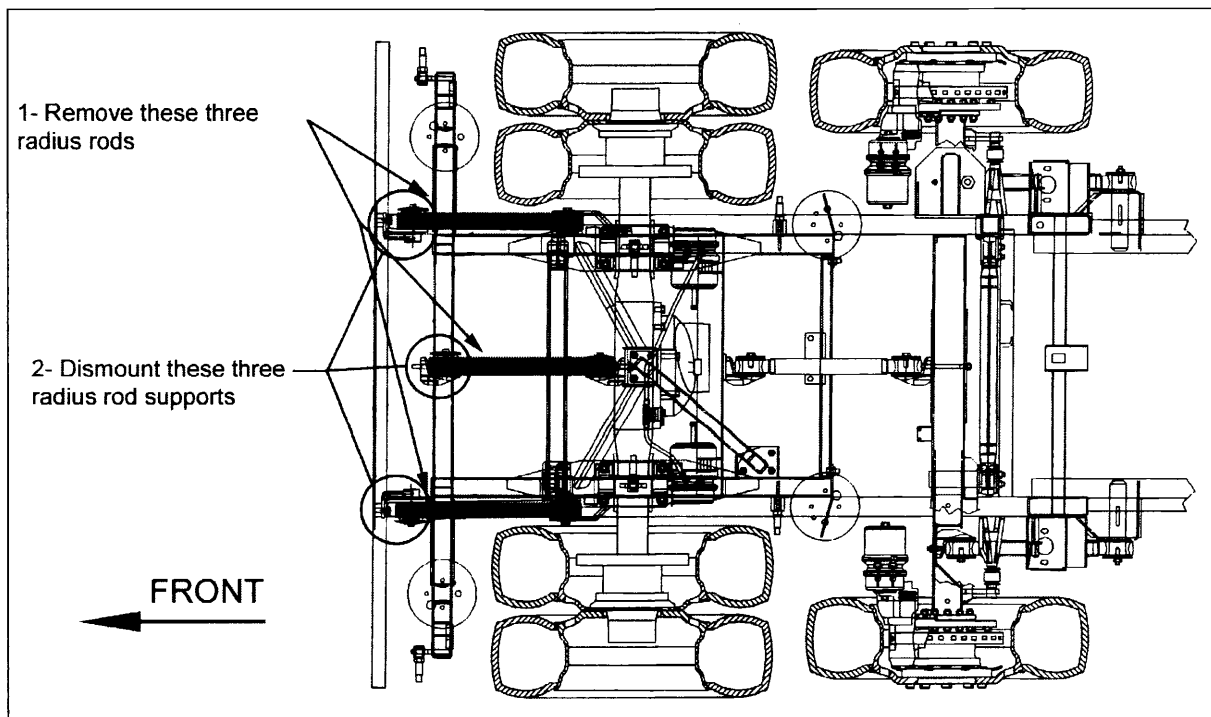
FIGURE 3: REAR SUSPENSION

For the above mentioned vehicles, Prevost Car has determined that a too large quantity of anti-seize compound has been used for mounting the 3 identified radius rod supports. The bolts securing the supports could come loose and the support may eventually detach from the structure. This could affect vehicle stability and cause a crash. It is necessary to dismount the radius rod supports, to remove all trace of anti-seize compound and to reinstall the supports according to the corrected factory procedure.

5. Dismount successively the 3 radius rods identified in figure 3 by flattening the tabs of locking plate and by unscrewing the two bolts directly fastened into radius rod pivot (if needed, refer to maintenance manual).

6. Dismount successively the 3 radius rod supports identified in figure 3. Take note of the position and quantity of shims in order to reinstall the components in the same condition as they were to maintain proper vehicle alignment.
