PREVOST

**SAFETY
RECALL**

Sr05-06

DATE : May-2005	SECTION : 16
SUBJECT : IMPROPER MOUNTING OF 3 RADIUS ROD SUPPORTS

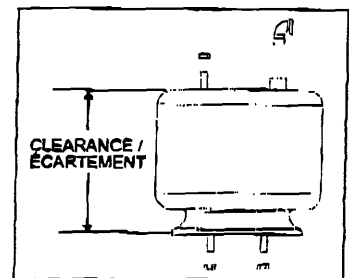
FIGURE 2: CLEARANCE

The normal ride height is obtained by measuring the clearance of the air springs. The clearance should be $11 \frac{1}{2} \pm \frac{1}{4}$ " for the air springs installed on the drive axle. The measure should be taken from under the upper air spring support on subframe to top of the lower air spring support on axle. See figure 2.

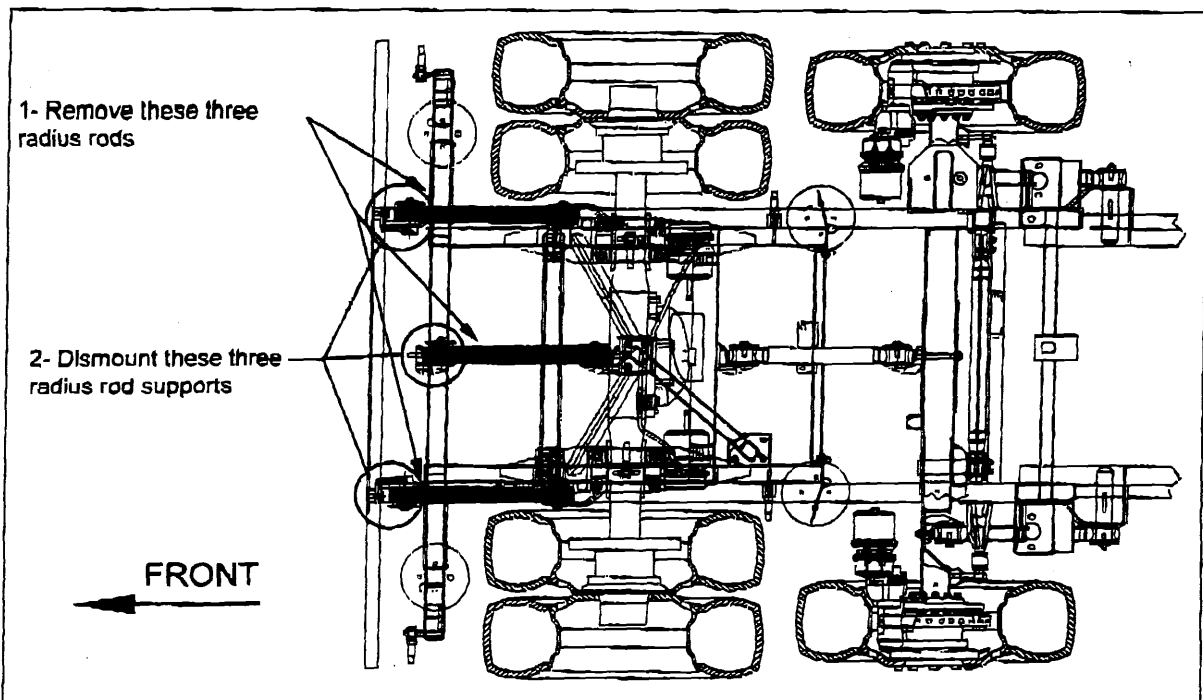
FIGURE 3: REAR SUSPENSION

For the above mentioned vehicles, PrevoSt Car has determined that a too large quantity of anti-seize compound has been used for mounting the 3 identified radius rod supports. The bolts securing the supports could come loose and the support may eventually detach from the structure. This could affect vehicle stability and cause a crash. It is necessary to dismount the radius rod supports, to remove all trace of anti-seize compound and to reinstall the supports according to the corrected factory procedure.

5. Dismount successively the 3 radius rods identified in figure 3 by flattening the tabs of locking plate and by unscrewing the two bolts directly fastened into radius rod pivot (if needed, refer to maintenance manual).

6. Dismount successively the 3 radius rod supports identified in figure 3. Take note of the position and quantity of shims in order to reinstall the components in the same condition as they were to maintain proper vehicle alignment.
