GM SERVICE AND PARTS OPERATIONS
DCS1378
URGENT DISTRIBUTE IMMEDIATELY

Subject: 05013 Product Safety Recall
 Multifunction Switch Contacts

Models: 2001-2002 Chevrolet Astro
 2001-2002 GMC Safari

SUBJECT: MULTIFUNCTION SWITCH CONTACTS

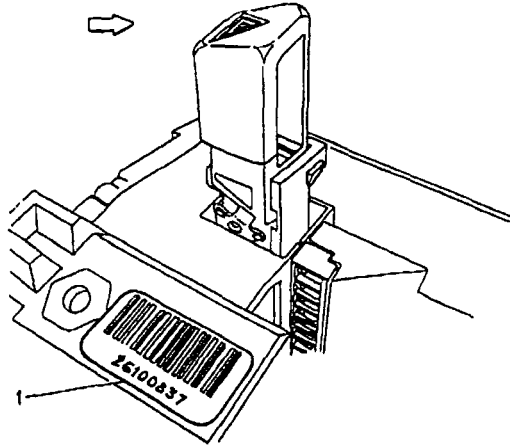
849940

Important: The illustration above is for the purpose of identifying the barcode only. The actual location of the barcode on the switch may differ.

35. Inspect the part number (1) on the multifunction switch at the location shown in the illustration.
 - If the part number is 26102157 or 26102158, no repair is required. Proceed to the section titled "Reassemble Vehicle."
 - If there is NO part number or barcode on the switch, or if the part number is 26084051 or 26084052, proceed to the next step and replace the hazard warning flasher switch using part number 15174447.
 - If the part number or barcode on the switch is 26091775, 26091776, 26096834, or 26096835, proceed to the next step and replace the hazard warning flasher switch using part number 15177379.

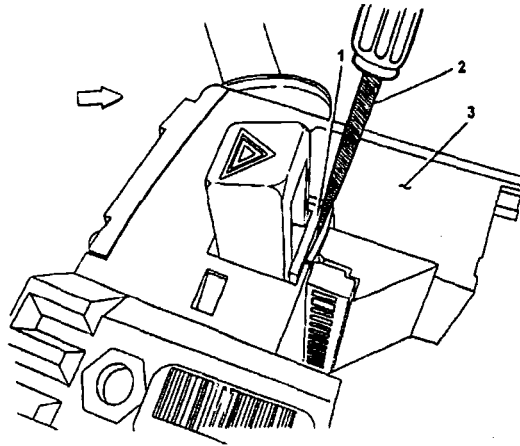
856061

Important: Carefully review the above illustration to determine the exact location to insert the screwdriver in the next step.

36. Insert a small, pocket-sized, flat bladed screwdriver (2) into the small space between the hazard warning flasher switch housing (1) and the multifunction switch (3).
37. Carefully tilt the screwdriver handle towards the instrument cluster. This will cause the blade of the screwdriver to pry open the space between the hazard warning flasher switch housing and the multifunction switch.
38. While the space is pried open, pull the hazard warning flasher switch out of the multifunction switch. Discard the hazard warning flasher switch.

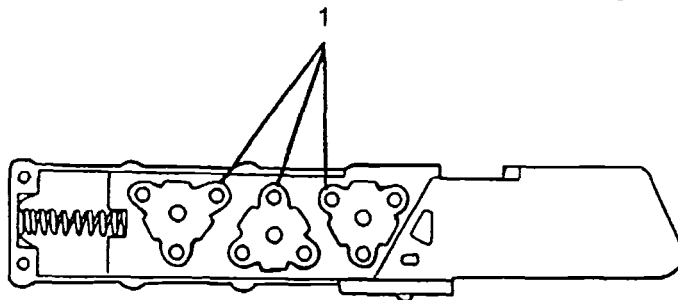
850585

Notice: Do not touch the three triangle-shaped electrical contacts (1) on the side of the switch when removing the protective packaging, handling, or applying grease to the new hazard warning flasher switch in the next steps.

40. Open the container of special grease included in the kit and apply it to the surfaces of the three triangle-shaped electrical contacts (1) on the side of the new hazard warning flasher switch. When properly applied, the surfaces of the three triangle-shaped electrical contacts must be completely covered and there should be no grease left in the container. DO NOT put any grease in the opening that contains the small metal return spring.
41. Insert the hazard warning flasher switch into the opening of the multifunction switch and press down until it locks into place.
42. Remove any excess grease that may appear around the base of the hazard warning flasher switch. Proceed to the next section "Reassemble Vehicle."
