**GM SERVICE AND PARTS OPERATIONS  
DCS1410  
URGENT - DISTRIBUTE IMMEDIATELY**

Subject: 05013A - Product Safety Recall  
Multifunction Switch Contacts  
Service Procedure Revision

Models: 2001-2002 Chevrolet Astro  
2001-2002 GMC Safari

**SUBJECT: MULTIFUNCTION SWITCH CONTACTS**

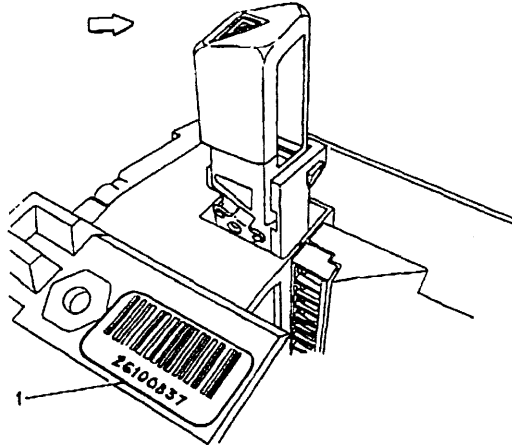
849940

**Important: The illustration above is for the purpose of identifying the barcode only. The actual location of the barcode on the switch may differ.**

35. Inspect the part number (1) on the multifunction switch at the location shown in the illustration.
  - If the part number is 26084051, 26084052, 26096834, 26096835, 26102157 or 26102158, no repair is required. Proceed to the section titled "Reassemble Vehicle."
  - If there is NO part number or barcode on the switch, no repair is required. Proceed to the section titled, "Reassemble Vehicle".
  - If the part number or barcode on the switch is 26091775 or 26091776, proceed to the next step and replace the hazard warning flasher switch using part number 15177379.

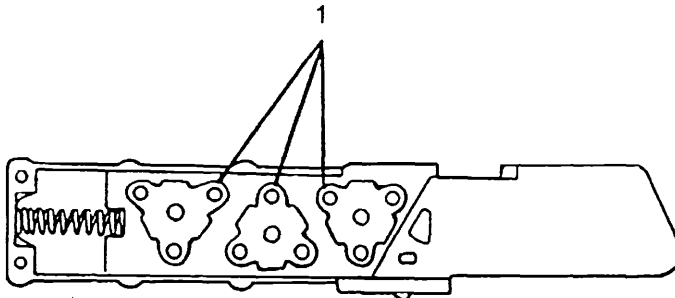
850585

**Notice:** Do not touch the three triangle-shaped electrical contacts (1) on the side of the switch when removing the protective packaging, handling, or applying grease to the new hazard warning flasher switch in the next steps.

**Important:** The electrical contacts on the new hazard warning flasher switch require a special lubricant, which is included in the kit. Only apply this special lubricant as instructed in the next step. **DO NOT** use any other type of grease or lubricant.

40. Open the container of special grease included in the kit and apply it to the surfaces of the three triangle-shaped electrical contacts (1) on the side of the new hazard warning flasher switch. When properly applied, the surfaces of the three triangle-shaped electrical

contacts must be completely covered and there should be no grease left in the container. DO NOT put any grease in the opening that contains the small metal return spring.
