# Recall Bulletin

## PRODUCT SAFETY RECALL

**SUBJECT:** BODY WIRING HARNESS CHAFING

**MODELS:** 2003-2005 CHEVROLET KODIAK  
 2003-2005 GMC TOPKICK  
 EQUIPPED WITH AIR BAGS (RPO AJ3 OR AK5)

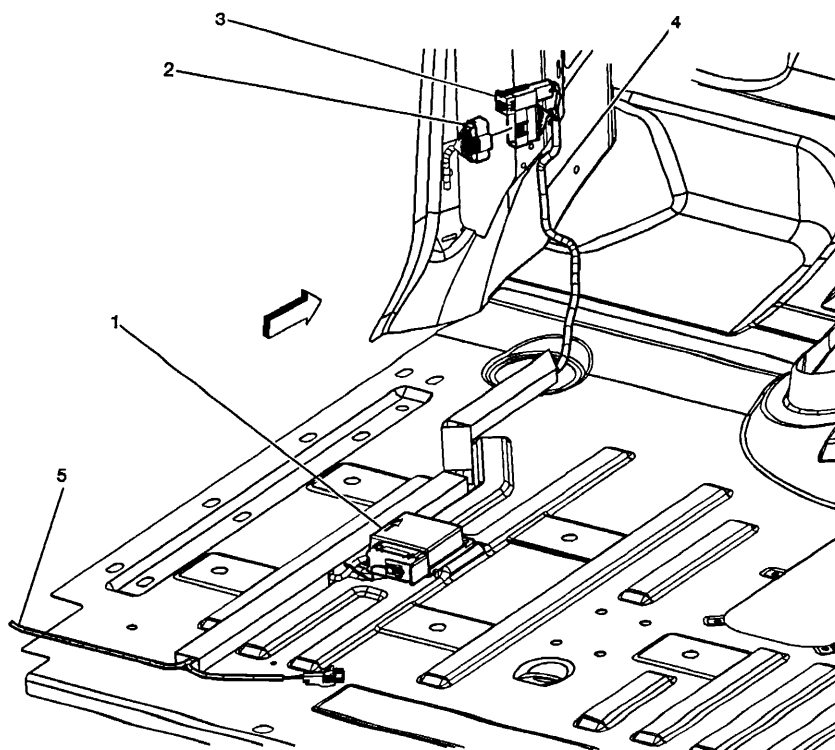
826952

9. Inspect the wire harness (4) from the connector to the plastic channel for signs of cuts or abrasions. Pay particular attention to the area that crosses the floor pan seam.
10. Repair any wires as necessary using approved wiring repair methods.
11. Get approximately 18 inches (45 cm) of ½" (12.7 mm) wire conduit.
12. Install the conduit over the exposed portion of the wires (4)

**Important:** Although the illustration shows the seat removed, there is no need to remove the seat to complete this repair.
