SUBJECT: Vehicle Safety Recall - SC0293
FXL Axle Dust Shield Bolt Interference - CXN model

VEHICLE RECALL

SC293

Subject: Interference Condition Between Front Axle Brake Dust Shield Mounting Bolt and Lower King Pin Boss — CXN Model Chassis with FXL12 or FXL14.6 Front Steer Axle and 16.5" x 5" Brakes

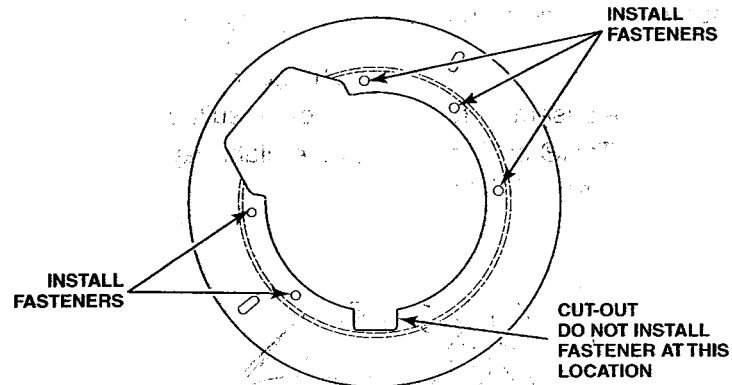
Figure 8 — Dust Shield Installation

It has been determined that on certain CXN model chassis equipped with either an FXL12 or FXL14.6 front axle and ArvinMeritor 16.5" x 5" brakes, the front axle brake dust shield mounting bolt may interfere with the lower king pin boss. To eliminate the interference, revised dust shields (part Nos. 8235-3264D1486, left-hand shield, and 8235-3264C1485, right-hand shield) must be used to replace the existing shield on all affected chassis. The revised dust shields have cutouts in the area of the lower mounting bolt.

4. Remove the existing dust shield from the spider.
5. Install the replacement dust shield (part Nos. 8235-3264D1486, left-hand side, and 8235-3264C1485, right-hand side) using five fasteners. Do not install a fastener in the bottom of the dust shield where it would contact the lower king pin boss.

The replacement dust shields are designed to provide adequate clearance between the lower king pin boss and the shield.
