**QUESTIONS AND ANSWERS FOR SAFETY CAMPAIGN (SC044)**

**SUBJECT:**  
RECALL CAMPAIGN: 2005 SPORTAGE ESP REPROGRAMMING

This bulletin provides information related to a recall campaign for 2WD and 4WD Sportage vehicles equipped with Electronic Stability Program (ESP) with production dates from 6/24/04 through 2/27/05.

Sportage vehicles within this production range may experience deceleration when driving or turning due to the sensitivity of the ESP logic. These Sportage vehicles ESP software logic must be reprogrammed to avoid this sensitivity of operation.

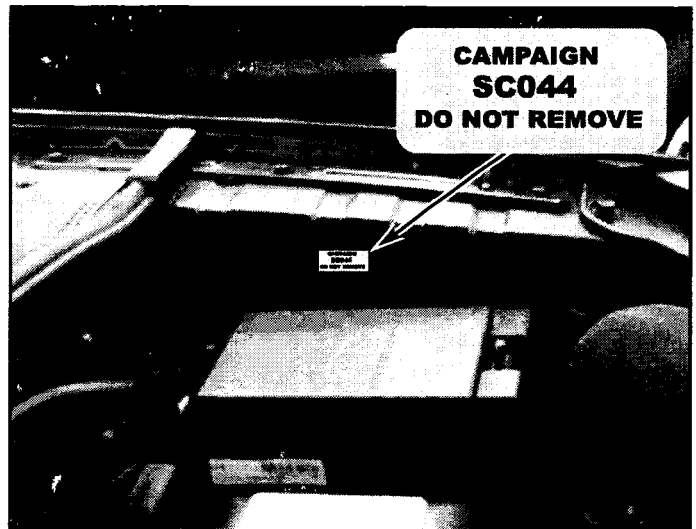
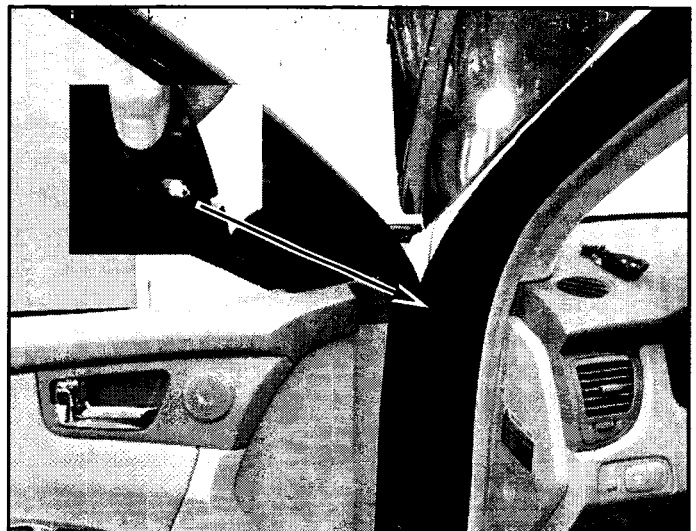
1. Open hood and check for SC044 Campaign Completion Label on the panel above the underhood fuse box.
  - If label exists, **NO FURTHER ACTION IS REQUIRED.**
  - If label **DOES NOT EXIST**, continue to Step 2.

2. Open driver's door, lift the weather strip on the driver's door and inspect for a small yellow paint dot on the window frame.
  - If paint dot exists, **NO FURTHER ACTION IS REQUIRED.**
  - If paint dot **DOES NOT EXIST**, continue to Steps 3-8.
