TOYOTA CUSTOMER SERVICES

Volume: XII
Number: TC05-009
Date: 04/13/2005
 Action
 Retain
 Information

SUBJECT: SPECIAL SERVICE CAMPAIGN (SSC) – 50E
(CERTAIN 2004 THROUGH EARLY 2005 MODEL YEAR TUNDRA WITH BOTH VSC
AND TRD DUAL EXHAUST SYSTEM)

**2004 THROUGH EARLY 2005 MODEL YEAR TUNDRA
WITH BOTH VSC AND TRD DUAL EXHAUST SYSTEM**

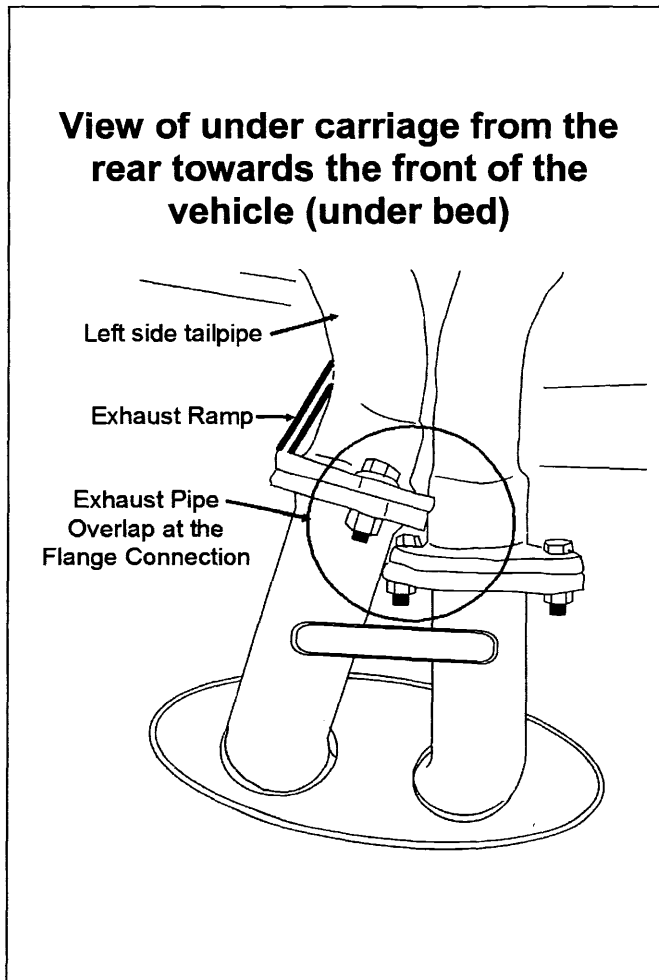
A. TRD DUAL EXHAUST SYSTEM INSPECTION

Vehicle must have both VSC and the original version of the TRD Dual Exhaust System for this repair to apply.

- (a) Check the left side tailpipe for an exhaust ramp, and that the left and right exhaust pipes overlap at the flange connection, as shown in the illustration.
- (b) If an exhaust ramp is present and the left and right exhaust pipes overlap, the vehicle has the updated TRD Dual Exhaust System installed. **NO** repairs are necessary.
- (c) If an exhaust ramp is **NOT** present and the left and right exhaust pipes **DO NOT** overlap, the vehicle has the affected TRD Dual Exhaust System installed. Continue to the next step for repair procedures

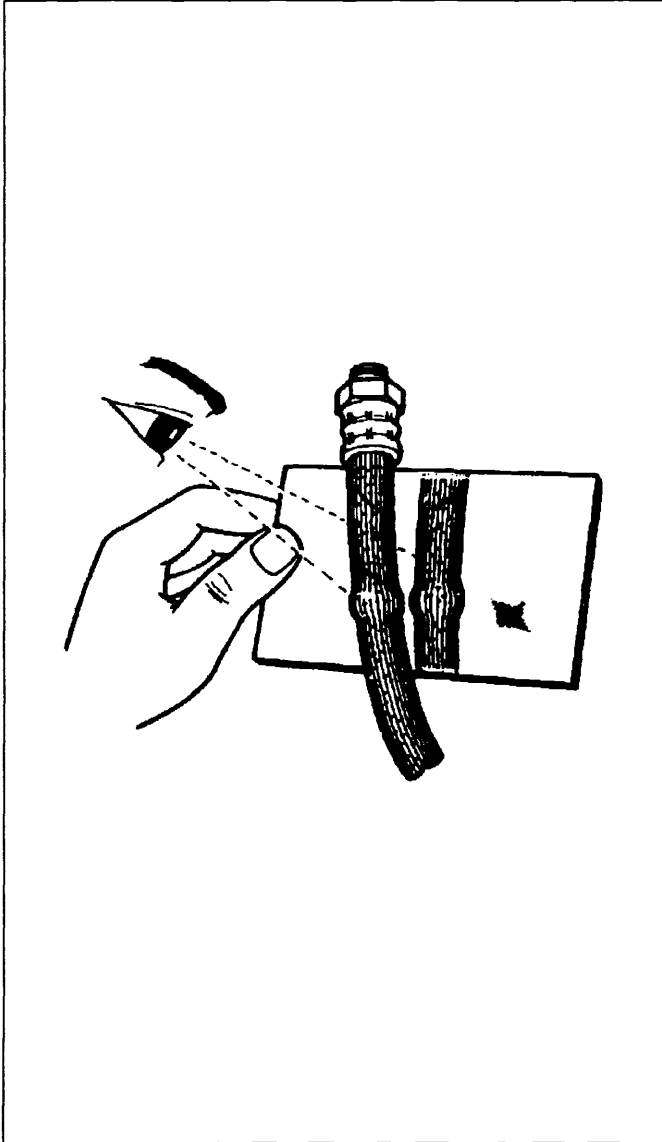
C. RIGHT REAR BRAKE HOSE INSPECTION

(a) In a well-lighted area, inspect the area of the right rear brake hose marked with the masking tape.

- Check the brake hose to see if it has come in contact with the exhaust pipe flange.
- Check the brake hose for any damage (cuts, scratches, rubbing, discoloration, bubbling, or burn marks) caused by the exhaust pipe flange.

(b) If the brake hose shows **NO** signs of contact or damage caused by the exhaust pipe flange, brake hose replacement is **NOT** needed, proceed to “**B. UPDATED DUAL EXHAUST SYSTEM INSTALLATION.**”

(c) If the brake hose shows signs of contact or damage caused by the exhaust pipe flange replace the brake hose, proceed to the next step.
