**Re: Defect Information Report (FL-442), NHTSA no. 05V-125**  
**Sterling rear axle wheel ends**

**Section 573.6 Defect Information Report**  
**FL-442, NHTSA no. 05V-125**  
**Supplement No.: 1**

March 2005  
FL442A-D  
NHTSA #05V-125

## Subject: Sterling Rear Axle Wheel Bearing Inspection and Adjustment

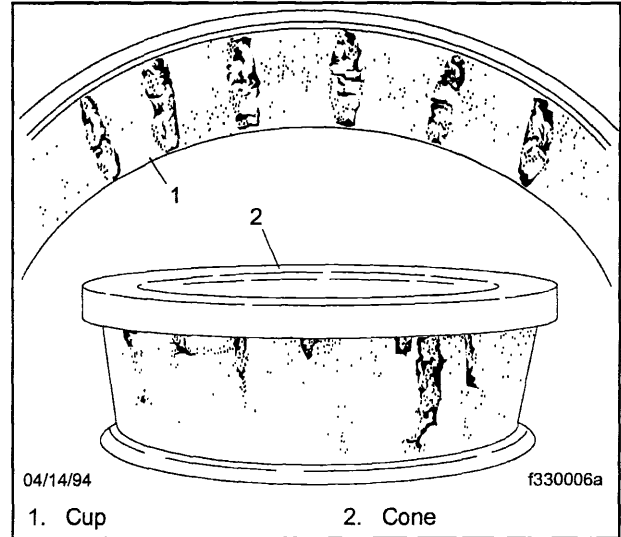
**Fig. 6, Spalling (Flaking) of Wheel Bearing Assembly**

- 3.3 After the bearings are cleaned, inspect the assemblies, which include the rollers, cones, cups, and cages. If any of the following conditions exist, replace the bearing assemblies:
- Large ends of rollers worn flush to the recess, or radii at the large ends of the rollers worn sharp (see Fig. 7);
  - Visible step wear, particularly at the small end of the roller track. Deep indentations, cracks, or breaks in the cone surfaces (see Fig. 8);
  - Bright rubbing marks on the dark phosphate surfaces of the bearing cage (see Fig. 9);
  - Water etch on any bearing surface. Water etch appears as gray or black stains on the steel surface, and it greatly weakens the affected area. If water etch is present, replace the bearing seals.
  - Etching or pitting on functioning surfaces (see Fig. 10);
  - Spalling (flaking) of the bearing cup, roller, or cone surfaces (see Fig. 6);

4. If any bearing damage is present, replace the bearings.
5. Check the axle spindle for damage to the threads. If damage is present, contact Warranty Campaigns for further instructions.
6. Install a new oil seal, the hub, and the bearings. For instructions, see **Group 35** in the applicable vehicle workshop manual.
7. Adjust the bearings, following the applicable instructions in these Work Instructions.
8. Go to step 12 under "General Procedure."
