*Ford Motor Company*

Subject: Safety Recall 05V-135  
(Ford Number 05S30)

**SUBJECT:** DEMONSTRATION / DELIVERY HOLD: Safety Recall 05S30:  
Certain 2005 Model Year F450/550 Vehicles  
Steering Gear Inspection/Replacement

## CERTAIN 2005 MODEL YEAR F-450 AND F-550 VEHICLES — STEERING GEAR INSPECTION

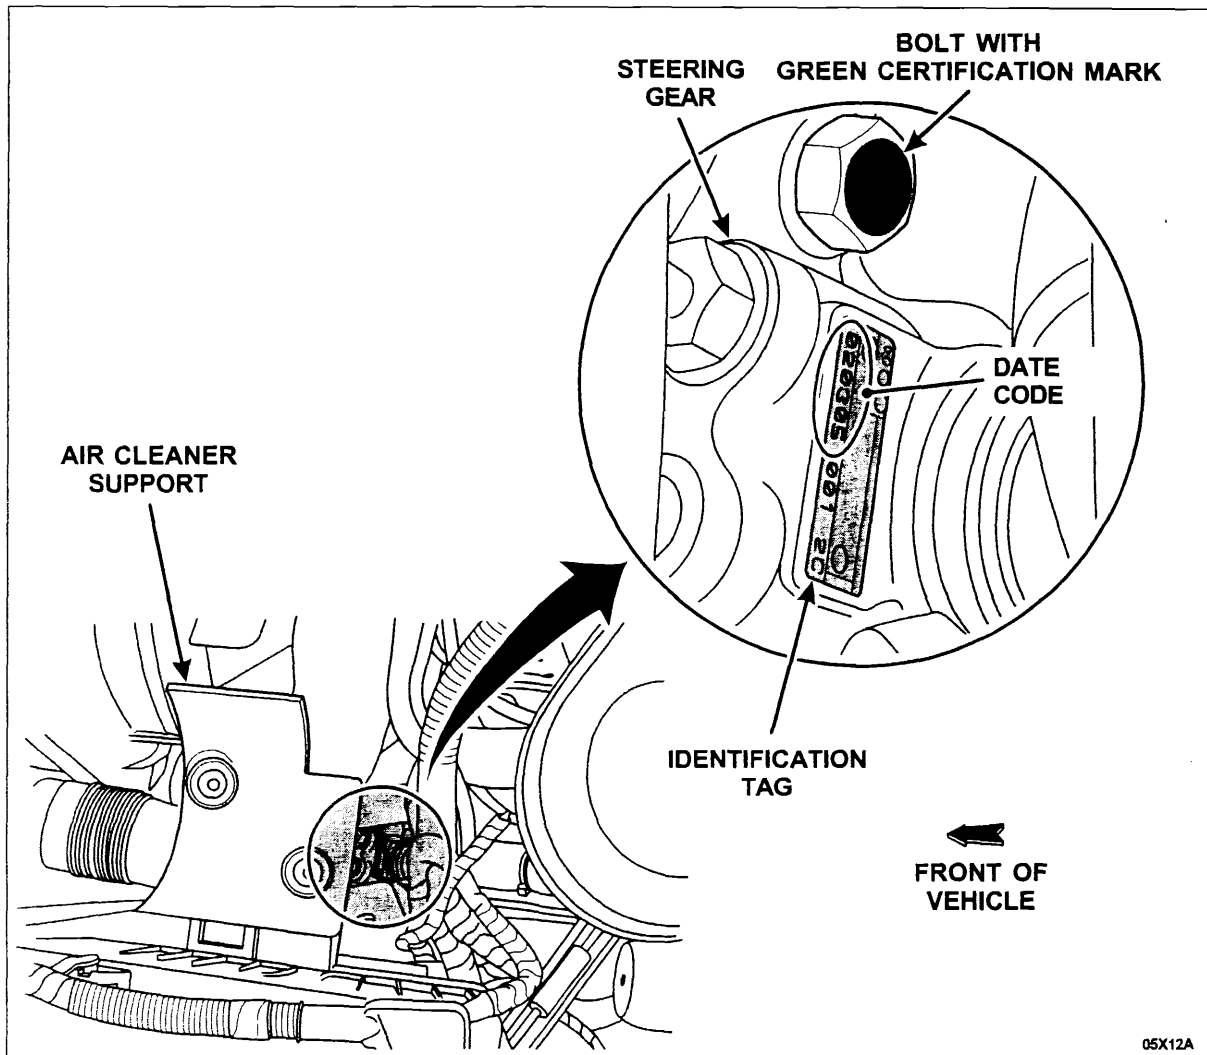
FIGURE 1

Locate the identification tag and read the date code (shown as DDMMYY). See Figure 1.

- If the date code indicates the gear was **not** built on March 2nd, 3rd or 4th 2005 (020305, 030305 or 040305), no further action is required. Reposition the steering gear coupling shield, reinstall the air cleaner assembly and release the vehicle.
- If the date code indicates the steering gear was built on March 2nd, March 3rd or March 4th, 2005 (020305, 030305 or 040305), check for a green certification mark on the bolt head just to the right of the ID tag.
  - If the green mark is present, no further action is required. Reposition the steering gear coupling shield, reinstall the air cleaner assembly and release the vehicle.
  - If the green mark is **not** present, the gear must be replaced. Proceed to Steering Gear Replacement in this Attachment III.
