## Product Recall

Subject: RECALL 05V-137, 05-078 (Canada #) Tie Rod Assembly

### Steer Axle Cross Link Assembly Replacement Instructions

## Product Recall Repair Procedure Recall 05V-137 05-078 - Tie Rod

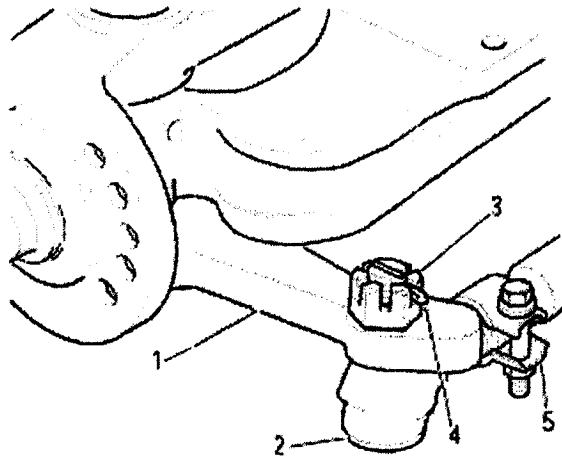
- 1 - Tie rod arm
- 2 - Tie rod end
- 3 - Slotted nut
- 4 - Cotter pin
- 5 - Position clamp fastener away from beam

1. Block the front and back of one of the vehicles tires.
2. Remove the tie rod end cotter pin from the slotted nut on the right and left sides of the cross link assembly.
3. Remove the slotted nut from both the tie rod ends.

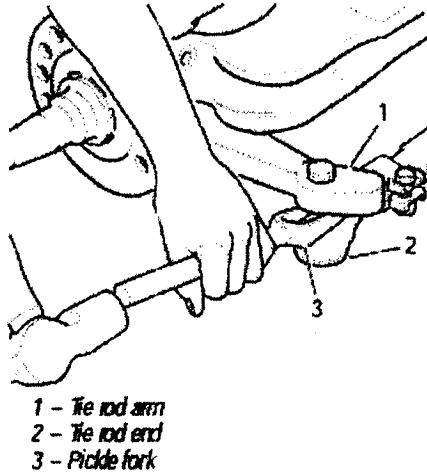
**Caution: Do not use heat on any axle parts or fasteners**

4. Disconnect the tie rod ends from the tie rod arms using a suitable tool such as a pickle fork.
