SERVICE BULLETIN

B-060

May 02, 2005

SAFETY RECALL CODE 0830 - SIDESTAND PIVOT BOLT FOR 2005 FIREBOLT XB12R AND LIGHTNING XB12S, XB9SX

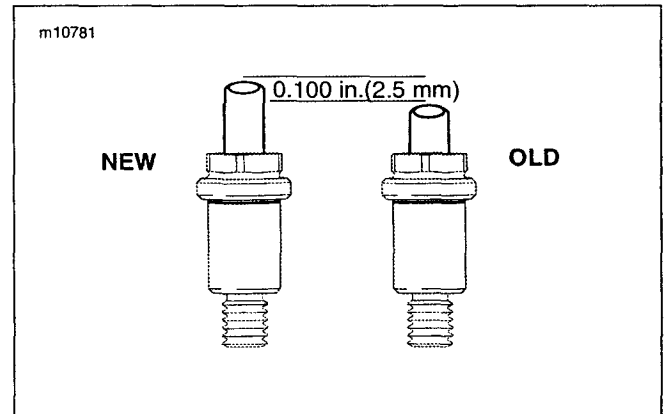
This campaign involves a small number of 2005 domestic and international Buell motorcycles manufactured from January 11th through January 17th, 2005. The sidestand may not retract 5 degrees as designed when the vehicle is lifted off the sidestand. This situation may not allow the sidestand to retract automatically if contact is made with the ground when the vehicle is in motion. This could in turn disrupt the stability of the motorcycle leading to a crash thereby, causing death or injury to the rider.

Figure 1. Correct Pivot Bolt with Springplate Pin

See Figure 1. Correcting the potential safety defect requires replacement of the sidestand pivot bolt, Part No. L0174.1AA. The replacement pivot bolt, Part No. L0174.1AAB, is 0.100 in. (2.5 mm) longer in the spring plate pin area and has a gold hue plating. **The recall kit Part No. is 94394Y.**

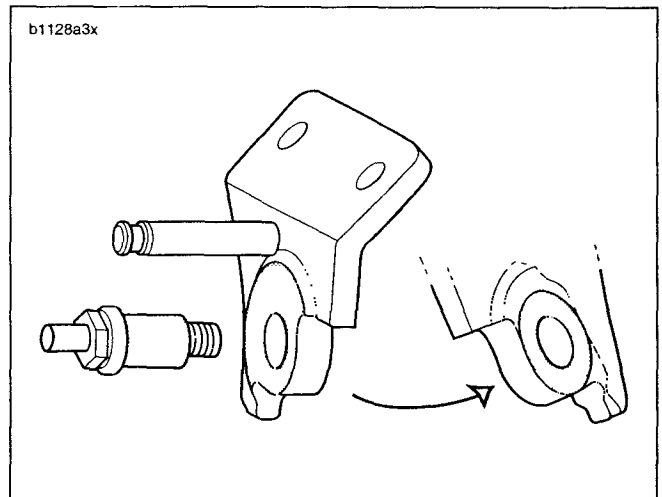
Figure 3. Lubricating Points (Shaded Areas)

1. Install **new** longer sidestand pivot bolt (4).
 - a. See Figure 3. Lubricate sidestand pivot bolt and mating portions on sidestand bracket with WHEEL BEARING GREASE (Part No. 99855-89) on shaded areas only.
 - b. See Figure 4. Apply LOCTITE 272 (Red) to threaded area (clevis) of sidestand leg.

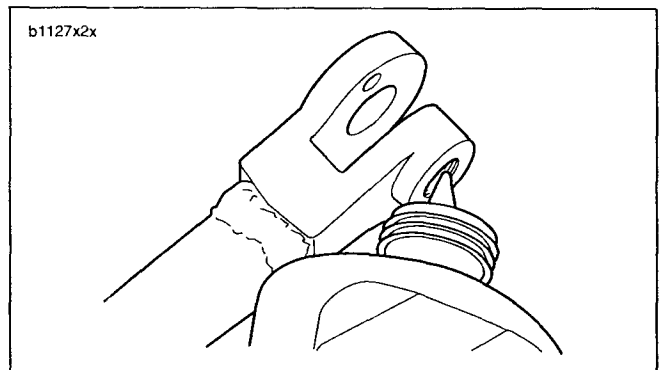
Figure 4. Threaded Area for Loctite Application

Applying LOCTITE to threaded area of clevis on sidestand leg, instead of threads on the pivot bolt, will eliminate build-up between clevis and sidestand bracket which can interfere with the applied lubricant.
