**Subject: Recall Campaign UU (05V-154)
1999-2000 Model Year Volkswagen Golf and GTI Vehicles Equipped
with a Gasoline Engine
Inspect Fuel Supply Module for Leaks and Install a Couple Piece (Connector) on
Fuel Line, Replace Fuel Supply Module if Necessary**

**Subject: Safety Recall UU
1999-2000 Model Year Volkswagen Golf and GTI Vehicles Equipped with a Gasoline Engine
Inspect Fuel Supply Module for Leaks and Install a Couple Piece (Connector) on Fuel Line;
Replace Fuel Supply Module if Necessary**

Code: **UU**

**Subject: 1999-2000 Model Year Volkswagen Golf & GTI Vehicles
Equipped with a Gasoline Engine
Inspect Fuel Supply Module for Leaks and Install a Couple Piece
(Connector) on Fuel Line; Replace Fuel Supply Module if Necessary**

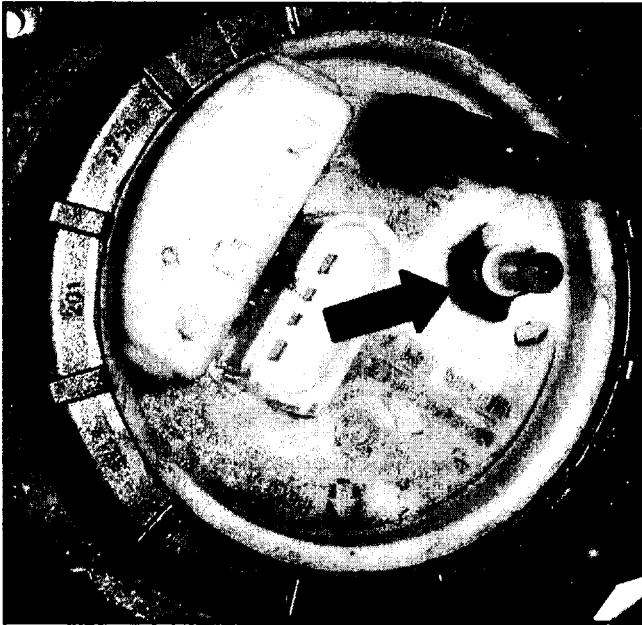
- Thoroughly clean and dry the fuel feed nipple and fuel supply module cover around the base of the nipple
- Visually check nipple for perpendicularity to the fuel supply module cover (not leaning outward) and make note of condition
- ⇐ Use a dry erase felt marker and color the lower part of the nipple and supply module cover around the base of the nipple -arrow-
- After a few seconds, wipe off ink

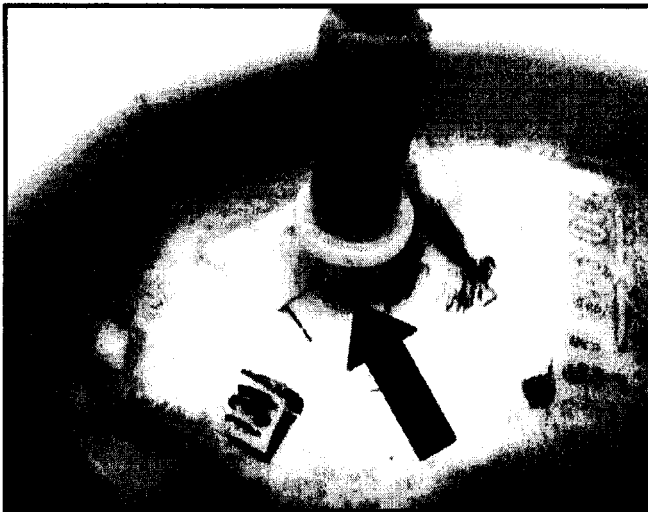
- ⇐ If a small ink line -arrow- at the base of the nipple is evident, a small crack is indicated; go to **Section B**
- If nipple is bent and there is no small ink mark or indication of a leak, do not replace the fuel supply module, go to **Section C**
- If the nipple is not bent and there is no small ink mark or indication of a leak, go to **Section C**
