# Recall Bulletin

## PRODUCT SAFETY RECALL

**SUBJECT: BRAKE PEDAL PUSHROD RETAINER**

**MODELS: 2005 BUICK ALLURE, LACROSSE**

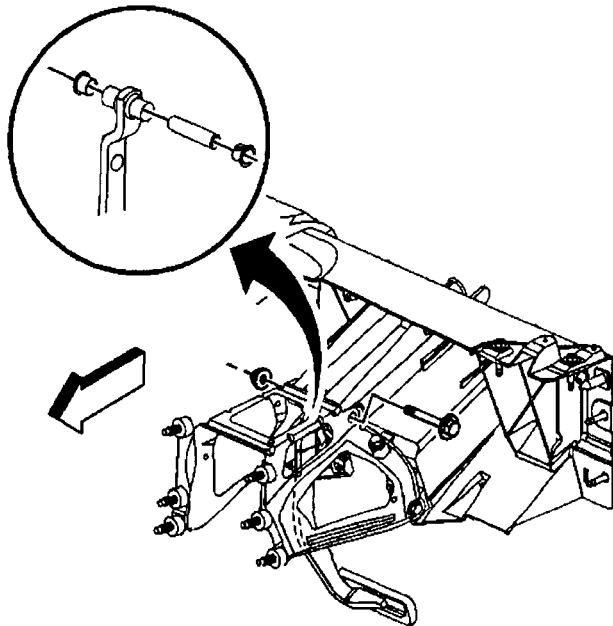
630032

1. Unplug and remove the brake pedal position sensor.
2. Remove the brake pedal pushrod and bushing from the brake pedal.

3. Remove the brake pedal nut and bolt.

**Important: It is not necessary to completely remove the bolt from the bracket. Leaving the bolt slightly engaged will assist in re-assembly.**
