Recall Bulletin

PRODUCT SAFETY RECALL

SUBJECT: SECOND ROW CENTER SAFETY BELT

**MODELS: 2003-2005 CADILLAC ESCALADE, ESCALADE ESV, ESCALADE EXT
 2003-2005 CHEVROLET AVALANCHE, SILVERADO CREW CAB,
 SUBURBAN, TAHOE
 2003-2005 GMC SIERRA CREW CAB, YUKON, YUKON XL
 2004-2005 HUMMER H2**

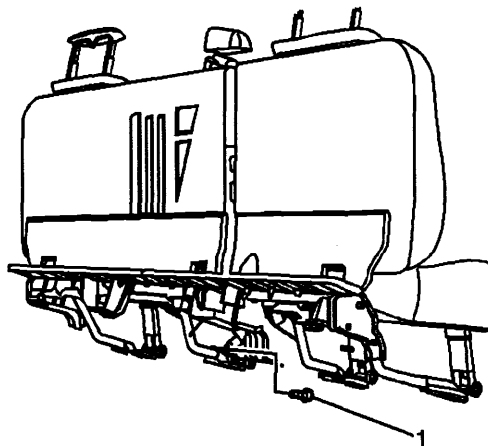
811814

General Motors has decided that a defect, which relates to motor vehicle safety, exists in **certain** 2003-2005 Cadillac Escalade, Escalade ESV, Escalade EXT; Chevrolet Avalanche, Silverado Crew Cab, Suburban, Tahoe; GMC Sierra Crew Cab, Yukon, Yukon XL; and 2004-2005 HUMMER H2 vehicles. On these vehicles, the seat loop in the second row center seating position may make it difficult to position the lap portion of the safety belt low around the hips of the occupant. In the event of a vehicle accident, if the lap portion of the safety belt routing is not low and snug on the hips, it may not properly restrain the occupant and could increase the risk of abdominal injury.

1. Note the position of the rear seats.
2. Position the seats to gain access to the lower seat belt anchor stud for the rear center seat.
3. Remove any cover necessary to gain access to the lower seat belt anchor point for the rear center seat.

4. Remove the nut (1) retaining the rear center seat's lower seat belt anchor (seat back shown in the up position).
5. Remove the belt anchor point from the stud.
6. Remove the belt from the seat loop on the front of the seat back cushion.
7. Route the belt outside of the seat loop and install it on the lower anchor stud. Be sure that the belt is not twisted.
8. Install the retaining nut to the anchor stud.

Tighten the retaining nut to 53 N·m (39 lb ft).
