**Re: Defect Information Report – supplemental information
(FL-448), NHTSA no. 05V-185, Accuride 29644ANP Wheels**

Section 573.6 Defect Information Report
FL-448, NHTSA no. 05V-185
Supplement No.: 1

Subject: Accuride 29644 ANP Aluminum Wheels

October 2005
 FL448A
 NHTSA #05V-185

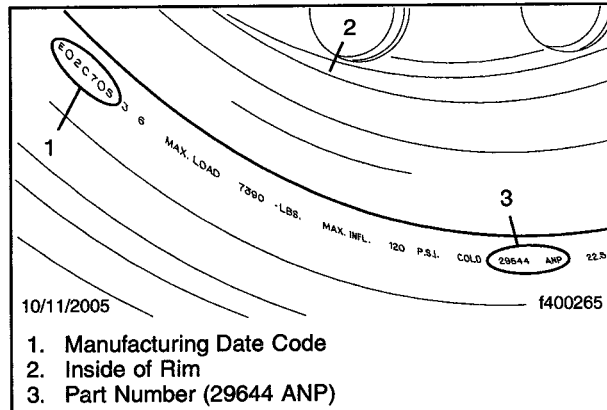
Fig. 1, Wheel Inspection (front wheel shown)

1. Park the vehicle on a level surface. Turn the steering wheel as far left as it can be turned. Shut down the engine, set the parking brake, and chock the tires. Open the hood.
2. Check the base label (Form WAR259) for a completion sticker for FL448 (Form WAR260) indicating this work has been done. The base label is usually located on the passenger-side door about 12 inches (30 cm) below the door latch. If a completion sticker is present, no further work is needed. If there is no completion sticker, go to the next step.
3. Inspect the wheels for the manufacturer's date stamp and part number 29644 ANP. The first six digits of the stamp are the manufacturing date (day, month, year). The manufacturing dates covered by this recall are January 15, 2005, through January 17, 2005 (one of these three date codes: 011505, 011605, or 011705). See Fig. 1.

- On the front axle, clean the inboard side of the front wheels and inspect.
- On tandem rear wheels, the inboard and outboard wheels are mounted back-to-back. To inspect the inboard tandem wheels, use a flashlight to look between the brake drum and the wheel. On the outboard wheels, the date stamp will be on the outside face.
- If the manufacturing date is **not** January 15, 2005, through January 17, 2005 (011505, 011605, or 011705), no further work is needed.

- If the manufacturing date is January 15, 2005, through January 17, 2005 (011505, 011605, or 011705), replace the wheel, following the procedures below.
4. Remove the disc wheel.
 - 4.1 If working on the front axle wheels, raise the front of the vehicle until the tires clear the floor. Place safety stands under the front axle.
