RE: Recall Number 05V-187 Defect Information Report (additional information)  
(Hyundai Campaign 069)

**Subject: Campaign 069 – 2005 MY Elantra and Tiburon – Steering Tie  
Rod Threaded Attachment**

# HYUNDAI Technical Service Bulletin

Group	CAMPAIGN
	Number	05-01-005
Subject	Date	MAY, 2005
	Model	2005 ELANTRA, 2005 TIBURON

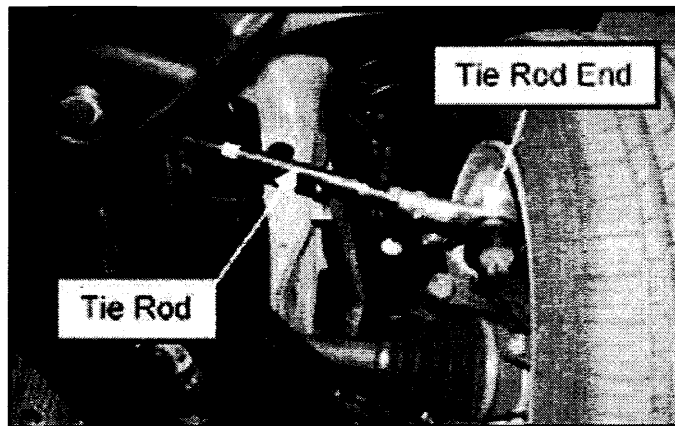
Some 2005 MY Elantra (XD) and Tiburon (GK) vehicles may have been manufactured with threaded portions of the steering gearbox assembly's left and right inner ball joint assemblies with internal cracks in the material structure. If the threaded portion of a steering gearbox assembly's inner ball joint assembly was to break as a result of the internal crack, the tie rod end assembly would no longer be attached to the steering gear box. This would prevent steering control of that front wheel by the separated tie rod.

This bulletin outlines the repair procedure for removal and replacement of the Steering Gear and Linkage Assembly with applicable part numbers.
