Product Recall

To: ALL DEALERS  
From: TRACY SAUERBREY - CUSTOMER SUPPORT DIVISION  
Subject: RECALL 05V-207 – 05-141 (Canadian) Webasto Coolant Heater  
Date: January 13, 2006

Recall 05V-207

Webasto's Process Instruction for the replacement of Burner Tube

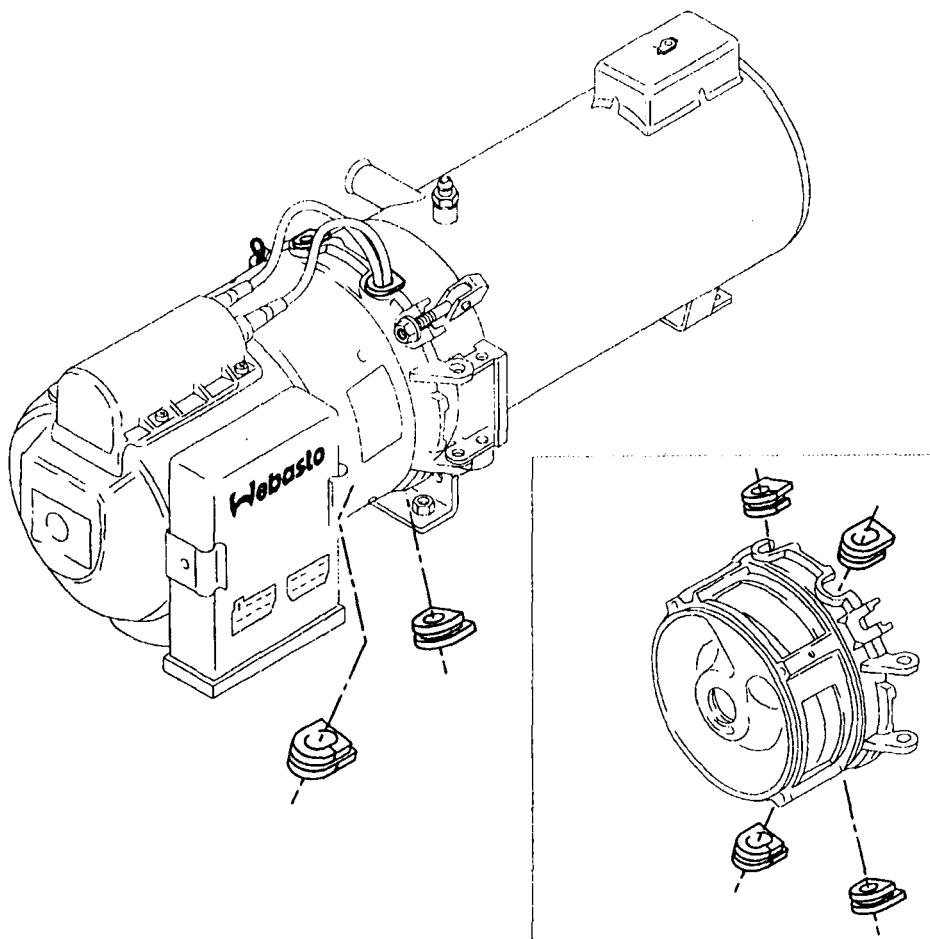
Figure 5

Once the burner head has been re-installed, make sure that all four grommets (2 right and 2 left) are in place. To minimize combustion air leakage, ensure grommets are fitted tightly around wire cables and fuel pipes. (see fig. 5).

In the case of the Scholastic Series heater with a **single line fuel system**, make sure the blank fuel pipe slot in the casting has a **solid (no hole) grommet** in place.
