SPECIAL SERVICE CAMPAIGN 50F

2005 MODEL YEAR AVALON
STEERING COLUMN ASSEMBLY INSPECTION

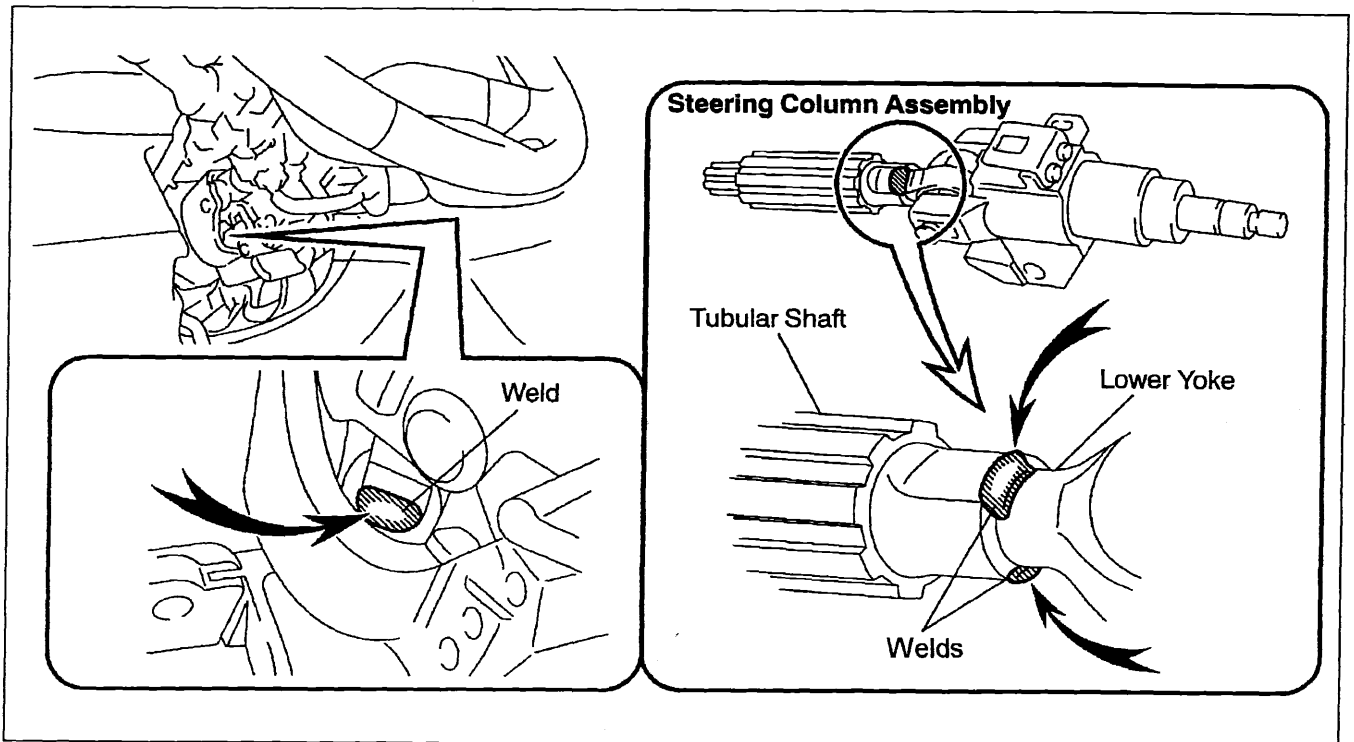
In a handful (less than three) of the early 2005 Model Year Avalon vehicles, there is a possibility that a portion of the steering column assembly may not have been welded correctly. The inspection procedure is to verify it is welded correctly.

- (a) Locate the opening on the steering column as shown in the illustration below, and insert the special flashlight.
- (b) Check that there are welds (see TIS video clip) present on the flat areas of each side of the shaft between the lower yoke and the tubular shaft, as shown in the illustration.

Weld marks are present:

Weld marks are missing:

- Steering column assembly is **OK**.
- Proceed to step "3. REINSTALL THE STEERING COLUMN COVERS."

- Steering column assembly is **NG**.
- Please call S. Brand in Quality Compliance at 310-468-7966.
