RECEIVE NVS-21 2005 JUN -9 A P J T OFFICE OF DEFECTS INVESTIGATION	<b>VOLUME</b> 3	<b>GROUP</b> Campaign	<b>MODEL</b> Sedona
		NUMBER 049	<b>DATE</b> May 2005	
<b>TECHNICAL SERVICE BULLETIN</b>				
<b>SUBJECT:</b> SAFETY RECALL CAMPAIGN: SEDONA EX REAR WHEEL BEARING

## SAFETY RECALL CAMPAIGN: SEDONA EX REAR WHEEL BEARING

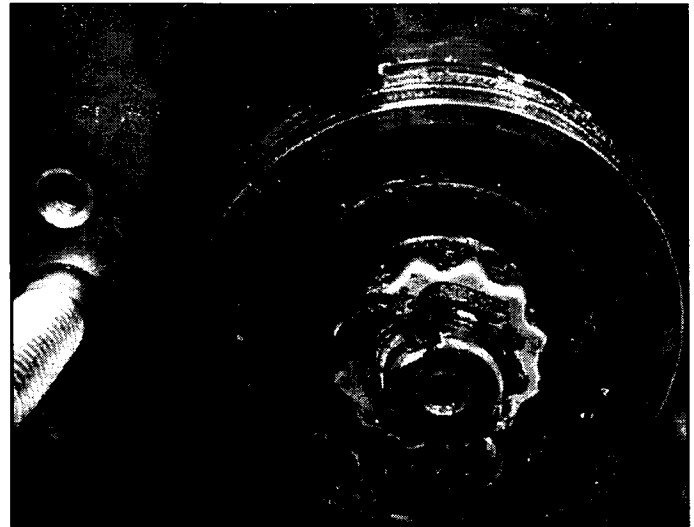
2. Raise vehicle on a hoist and remove the rear wheels.
3. Remove both hubcaps and discard. Inspect exposed hub and bearing area on left and right sides for any sign of moisture, corrosion, grease discoloration or contamination (see photo). If "yes" or if hub shows signs of binding or other bearing failure during rotation, then proceed to Hubcap & Outer Bearing Replacement Procedure, if "no" then proceed to Step 4.

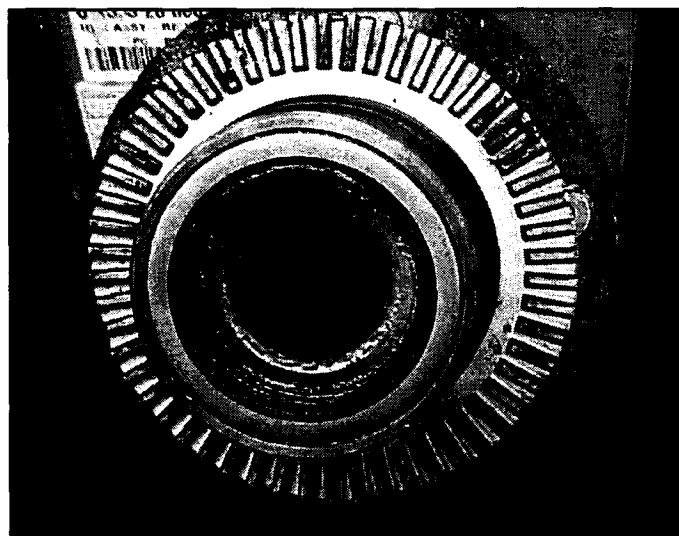
4. Remove nut, claw washer, outer bearing and hub assembly.
5. Inspect inner bearing area in both hubs for any sign of moisture, corrosion, grease discoloration or contamination. If "yes" discard entire hub and replace with new assembly. If "no" proceed with outer bearing replacement below:
