## SERVICE REPAIR PROCEDURE

<b>30" C.E. WHITE BARRIER WELD REPAIR</b>		<b>RECALL # 05V-255</b>	
<b>BY:</b> Jose Vazquez	<b>DEPARTMENT:</b> Warranty	<b>DATE:</b> 3/4/2010	<b>REVISION:</b> 3

2000- 2006 US Bus Corporation Sturdibus School Buses

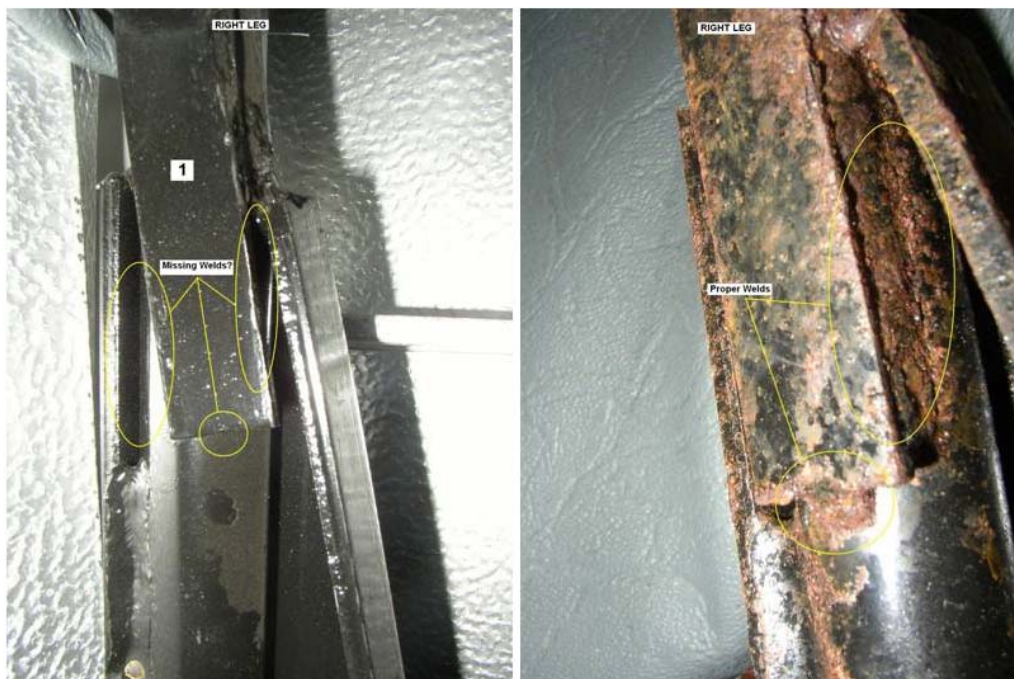
*Figure A*

The non-compliance relates to failure of the Forward Impact Barrier, manufactured by C.E. White Corporation, to absorb the required level of energy within the deflection range, as defined by Federal Motor Vehicle Safety Standard No. 222 "School Bus Passenger Seating and Crash Protection". The 30-inch barriers frames were manufactured incorrectly, whereby certain critical welds were not performed in critical areas.

- 1) Locate the barrier floor leg section that consists of a 1" outside diameter round tube extending down from the upholstered back, a formed metal boot in the shape of a "C" that is approximately 11.75" tall, a flat footpad with a series of holes to mount the leg to the floor, and a 7 gage x 0.75" flat steel plate that extends down from the upholstered back and extends approximately 1.50" beyond the top of the boot. This area is fully exposed below the upholstery line and should be very visible.
- 2) At the end of the flat steel plate below the top of the boot, there should be a 0.75" weld across the bottom and extending vertically up the backside by at least 0.38", Otherwise there should be 1.12" of vertical weld at the seam of the plate and tube on the backside of the barrier frame. If this amount of weld is not present, then proceed to the Repair Steps and follow instructions.

**Welds Missing**

**Proper Welds**

- 2) Prepare the seam for weld between the end of the flat plate and round tube by removing all paint from surface using a wire wheel on the end of an air, battery or electric hand tool,
- 3) With proper welding equipment, place a 1.12" length of vertical weld along the backside of the barrier frame at the seam location shown in figure "A". Use an electrode of E70 or better for sufficient weld strength.
