# RECALL BULLETIN 05V-262

DATE: SEPTEMBER 12, 2005  
 MODEL YEAR: 1999 thru Early Production 2002  
 CHASSIS MODEL: UD1200/UD1400  
 BULLETIN NUMBER: SC-262

## VOLUNTARY SAFETY RECALL CAMPAIGN NUMBER 05V-262: BATTERY CABLE INSPECTION AND/OR REPLACEMENT

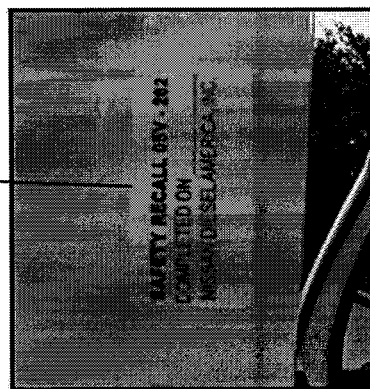
**Figure A**

- If the involved vehicle has a label on the inside of the driver's door as shown in Figure A, the recall has already been performed and no further action is required.
- If the involved vehicle does not have the label on the inside of the driver's door, verify through the Vehicle Service Notification screen of the NDANET2 system that the recall is required. Complete the safety recall according to the following instructions.

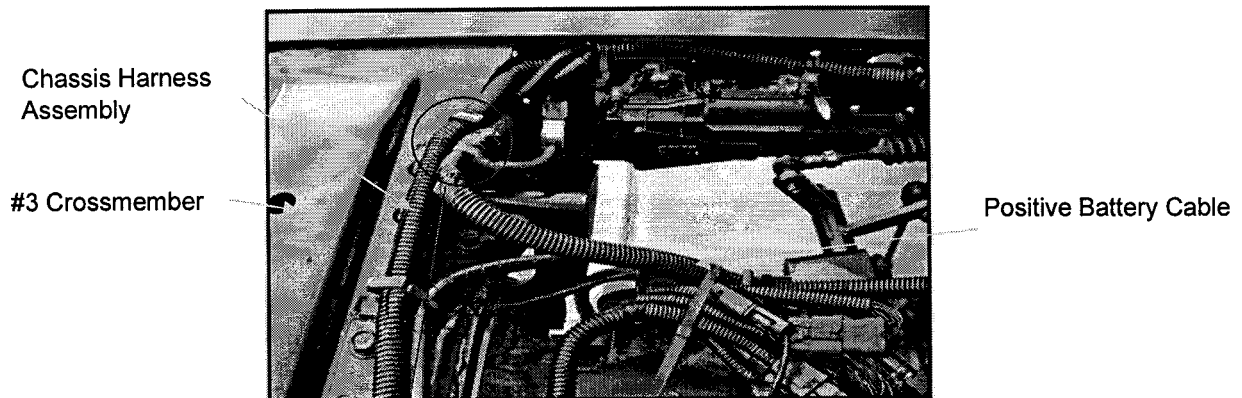
Figure A1 (1999 & 2000 MY)

If the battery cable is not damaged inspect the Positive Battery Cable for proper routing as illustrated in Figure A1 and A2. Re-route the cable correctly as necessary. Proceed to Step 3.

Clamp the battery cable securely with the Chassis Harness to the cross member using the welded harness clip.

NOTE\*: If the 3<sup>rd</sup> frame cross member is missing the welded retaining clip or is broken, use a Tie Strap PN 01552-00043 (from the Safety Recall Parts Kit) to secure the battery cable to the chassis harness as shown in Figure A2.
