SUBJECT: Campaign #95 –Rear Suspension Air Bag Upper Mount Reinforcement

**Instructions to Perform Campaign 95
2006 Winnebago View & Itasca Navion
(500-Series)
Air Bag Bracket Reinforcement**

Air Bag Bracket Reinforcement Kit-Part #RC7665-05-795

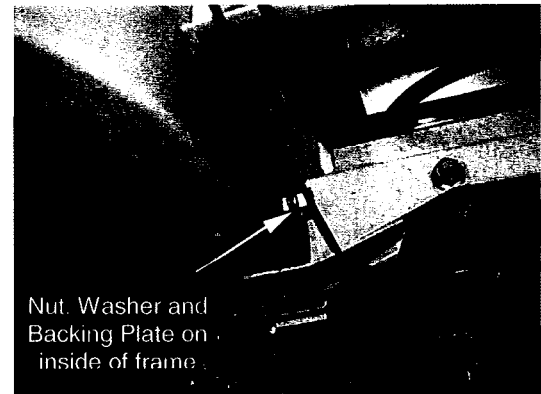
- 8) Tighten the nut and bolt running through the frame rail (photo 9506) **until the new parts are snug, then tighten one additional turn only.**
