August 17, 2005

SUBJECT: Safety Recall 05S34: Supplement #3
Certain 2004 Model Year F250/350/450/550, Excursion, and E350/450 Vehicles
Equipped with 6.0L Diesel
Fuel Injector Control Module Wiring Harness Repair

Safety Recall 05S34-S3
Certain 2004 Model Year F250/350/450/550, Excursion, and E350/450 Vehicles
Fuel Injector Control Module Wiring Harness Repair

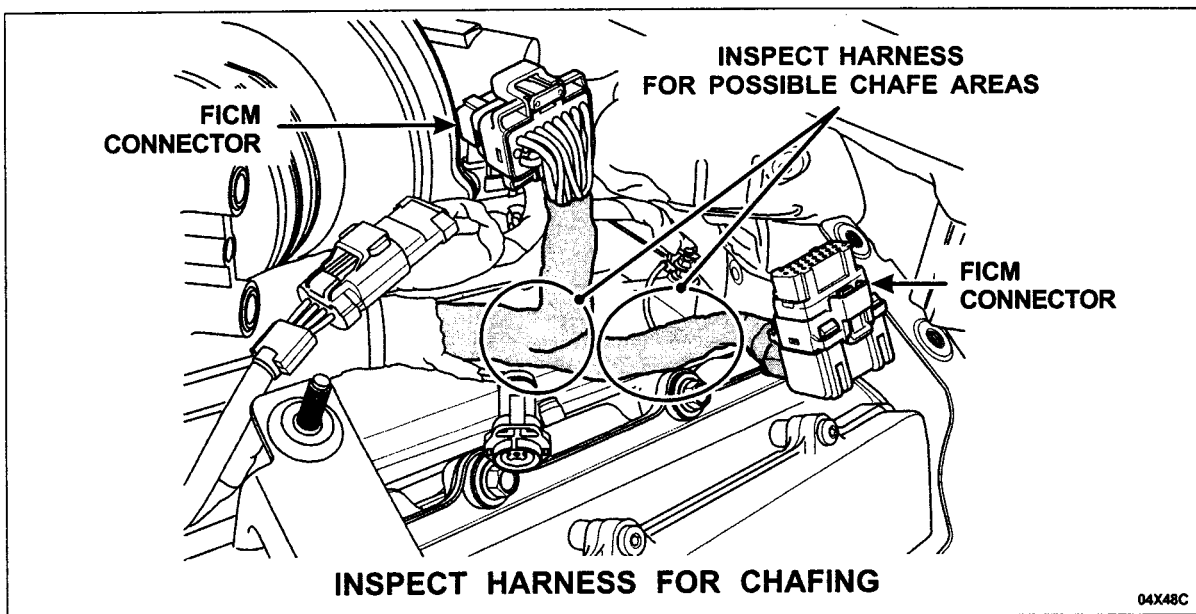
FIGURE 4

This program involves inspecting the fuel injector harness, at the fuel injection control module (FICM), for chafing caused by the harness rubbing against the intake manifold or rocker cover assembly bolt heads. If only a light amount of chafing has occurred (tape is worn through, the silver shielding and possibly the wire insulation are visible), install protective shields to prevent further damage. If more extensive chafing has occurred (copper wire strands are visible), the harness must be replaced.

9. Inspect the underside of the injector harness in the two (2) areas noted in the illustration. See Figure 4.

- If the harness is either NOT chafed or only lightly chafed but the copper wire strands ARE NOT visible (outer vinyl tape and possibly the silver-colored shield is worn through), the Harness Protection Kit 4C3Z-14A099-A must be installed. Proceed to FICM Harness Protection Kit Installation in this Attachment IV.
- If extensive chafing has occurred which has exposed the copper strands, the harness must be replaced. Do not attempt to repair a chafed harness if these conditions are found. Proceed to FICM Harness Replacement in this Attachment IV.

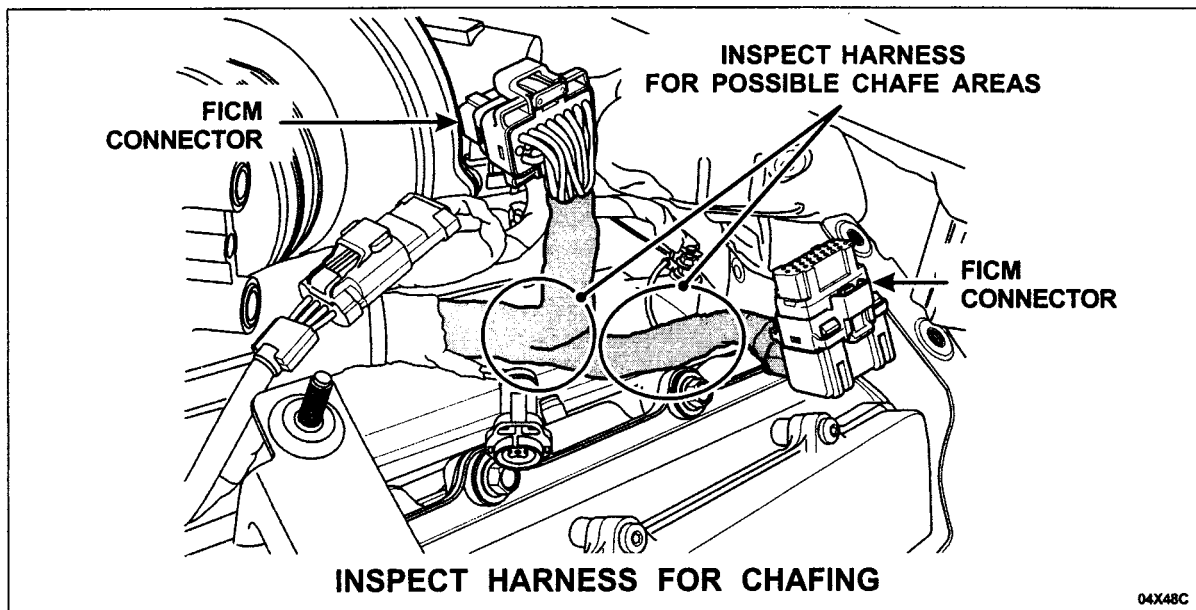
FIGURE 4

This program involves inspecting the fuel injector harness, at the fuel injection control module (FICM), for chafing caused by the harness rubbing against the intake manifold or rocker cover assembly bolt heads. If only a light amount of chafing has occurred (tape is worn through, the silver shielding and possibly the wire insulation are visible), install protective shields to prevent further damage. If more extensive chafing has occurred (copper wire strands are visible), the harness must be replaced. This program also involves replacing the injector control pressure (ICP) sensor connector assembly. The harness connector is replaced utilizing the Rotunda Wire Splice Tool Kit 164-R5903.

9. Inspect the underside of the injector harness in the two (2) areas noted in the illustration. See Figure 4.

- If the harness is either NOT chafed or only lightly chafed but the copper wire strands ARE NOT visible (outer vinyl tape and possibly the silver-colored shield is worn through), the Harness Protection Kit 4C3Z-14A099-A must be installed. Proceed to FICM Harness Protection Kit Installation in this Attachment V.
- If extensive chafing has occurred which has exposed the copper strands, the harness must be replaced. Do not attempt to repair a chafed harness if these conditions are found. Proceed to FICM Harness Replacement in this Attachment V.
