Frank M. Ligon  
Director  
Service Engineering Operations  
Ford Customer Service Division

July 5, 2005

**SUBJECT:** Safety Recall 05S34: Supplement #1  
Certain 2004 Model Year F250/350/450/550, Excursion, and E350/450 Vehicles  
Equipped with 6.0L Diesel  
Fuel Injector Control Module Wiring Harness Repair

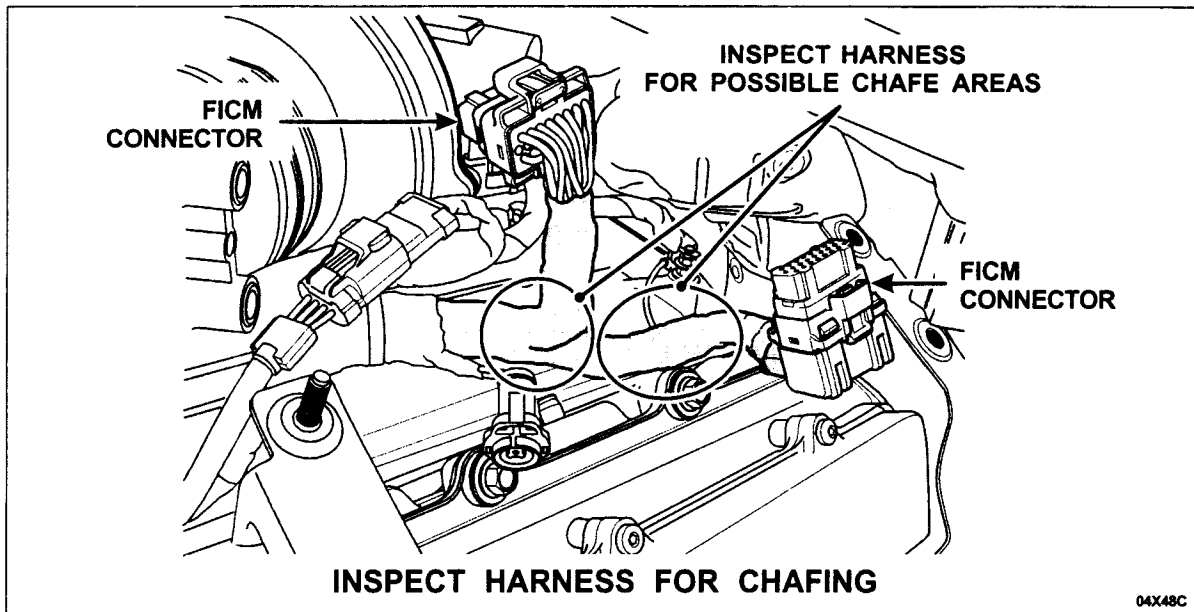
FIGURE 4

This program involves inspecting the fuel injector harness, at the fuel injection control module (FICM), for chafing caused by the harness rubbing against the intake manifold or rocker cover assembly bolt heads. If only a light amount of chafing has occurred (tape is worn through, the silver shielding and possibly the wire insulation are visible), install protective shields to prevent further damage. If more extensive chafing has occurred (copper wire strands are visible), the harness must be replaced.

9. Inspect the underside of the injector harness in the two (2) areas noted in the illustration. See Figure 4.

- If the harness is either NOT chafed or only lightly chafed but the copper wire strands ARE NOT visible (outer vinyl tape and possibly the silver-colored shield is worn through), the Harness Protection Kit 4C3Z-14A099-A must be installed. Proceed to FICM Harness Protection Kit Installation in this Attachment IV.
- If extensive chafing has occurred which has exposed the copper strands, the harness must be replaced. Do not attempt to repair a chafed harness if these conditions are found. Proceed to FICM Harness Replacement in this Attachment IV.

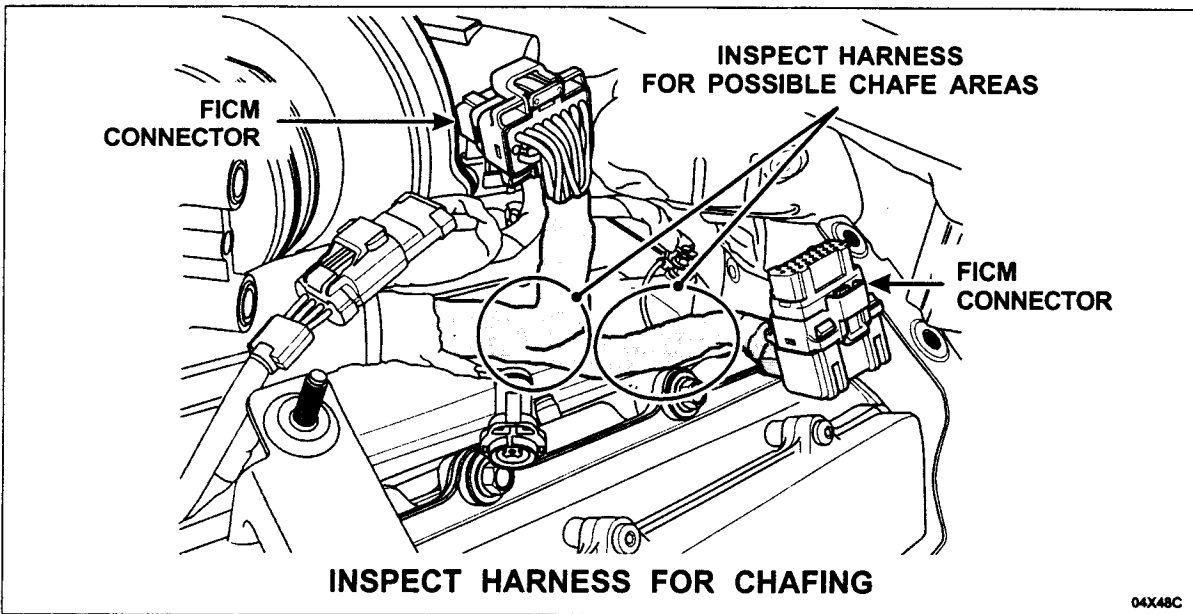
FIGURE 4

This program involves inspecting the fuel injector harness, at the fuel injection control module (FICM), for chafing caused by the harness rubbing against the intake manifold or rocker cover assembly bolt heads. If only a light amount of chafing has occurred (tape is worn through, the silver shielding and possibly the wire insulation are visible), install protective shields to prevent further damage. If more extensive chafing has occurred (copper wire strands are visible), the harness must be replaced. This program also involves replacing the injector control pressure (ICP) sensor connector assembly. The harness connector is replaced utilizing the Rotunda Wire Splice Tool Kit 164-R5903.

9. Inspect the underside of the injector harness in the two (2) areas noted in the illustration. See Figure 4.

- If the harness is either NOT chafed or only lightly chafed but the copper wire strands ARE NOT visible (outer vinyl tape and possibly the silver-colored shield is worn through), the Harness Protection Kit 4C3Z-14A099-A must be installed. Proceed to FICM Harness Protection Kit Installation in this Attachment V.
- If extensive chafing has occurred which has exposed the copper strands, the harness must be replaced. Do not attempt to repair a chafed harness if these conditions are found. Proceed to FICM Harness Replacement in this Attachment V.
