- TO:** All U.S. Ford and Lincoln Mercury Dealers
- SUBJECT:** Safety Recall 05S34: Supplement #2
Certain 2004 Model Year F250/350/450/550, Excursion, and E350/450 Vehicles
Equipped with 6.0L Diesel
Fuel Injector Control Module Wiring Harness Repair

REASON FOR THIS SAFETY RECALL

Safety Recall 05S34-S2
Certain 2004 Model Year F250/350/450/550, Excursion, and E350/450 Vehicles
Fuel Injector Control Module Wiring Harness Repair

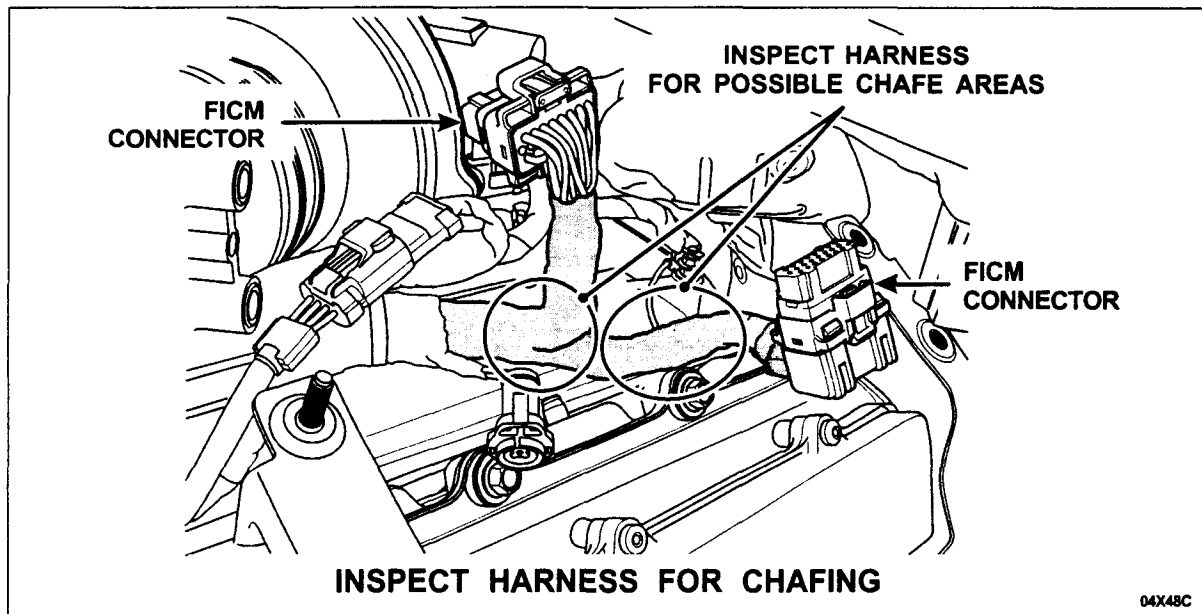
FIGURE 4

This program involves inspecting the fuel injector harness, at the fuel injection control module (FICM), for chafing caused by the harness rubbing against the intake manifold or rocker cover assembly bolt heads. If only a light amount of chafing has occurred (tape is worn through, the silver shielding and possibly the wire insulation are visible), install protective shields to prevent further damage. If more extensive chafing has occurred (copper wire strands are visible), the harness must be replaced.

9. Inspect the underside of the injector harness in the two (2) areas noted in the illustration. See Figure 4.

NOTE: The harness is constructed of a bundle of insulated copper wires wrapped in a grounded silver-colored shield (much like heavy gauge aluminum foil), then covered with a wrapping of black vinyl tape.

- If the harness is either NOT chafed or only lightly chafed but the copper wire strands ARE NOT visible (outer vinyl tape and possibly the silver-colored shield is worn through), the Harness Protection Kit 4C3Z-14A099-A must be installed. Proceed to FICM Harness Protection Kit Installation in this Attachment IV.
- If extensive chafing has occurred which has exposed the copper strands, the harness must be replaced. Do not attempt to repair a chafed harness if these conditions are found. Proceed to FICM Harness Replacement in this Attachment IV.

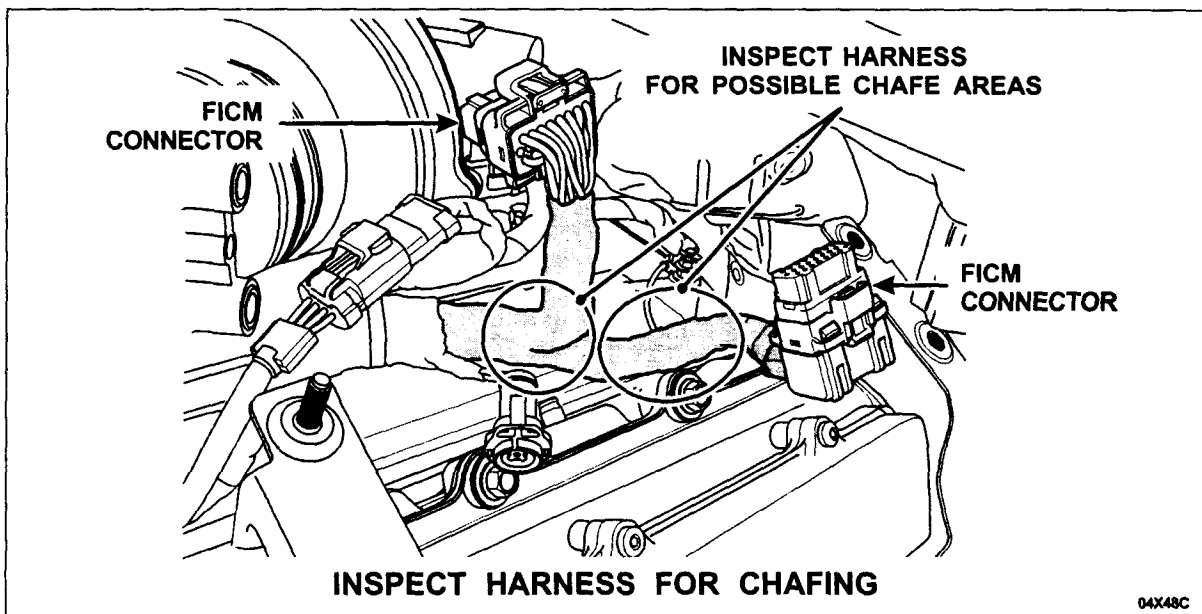
FIGURE 4

This program involves inspecting the fuel injector harness, at the fuel injection control module (FICM), for chafing caused by the harness rubbing against the intake manifold or rocker cover assembly bolt heads. If only a light amount of chafing has occurred (tape is worn through, the silver shielding and possibly the wire insulation are visible), install protective shields to prevent further damage. If more extensive chafing has occurred (copper wire strands are visible), the harness must be replaced. This program also involves replacing the injector control pressure (ICP) sensor connector assembly. The harness connector is replaced utilizing the Rotunda Wire Splice Tool Kit 164-R5903.

9. Inspect the underside of the injector harness in the two (2) areas noted in the illustration. See Figure 4.

NOTE: The harness is constructed of a bundle of insulated copper wires wrapped in a grounded silver-colored shield (much like heavy gauge aluminum foil), then covered with a wrapping of black vinyl tape.

- If the harness is either NOT chafed or only lightly chafed but the copper wire strands ARE NOT visible (outer vinyl tape and possibly the silver-colored shield is worn through), the Harness Protection Kit 4C3Z-14A099-A must be installed. Proceed to FICM Harness Protection Kit Installation in this Attachment V.
- If extensive chafing has occurred which has exposed the copper strands, the harness must be replaced. Do not attempt to repair a chafed harness if these conditions are found. Proceed to FICM Harness Replacement in this Attachment V.
