# Ford Motor Company

Subject: Safety Recall 05V-270  
(Ford Number 05S34)

**SUBJECT:** Safety Recall 05S34:  
Certain 2004 Model Year F250/350/450/550, Excursion, and E350/450 Vehicles  
Equipped with 6.0L Diesel  
Fuel Injector Control Module Wiring Harness Repair

Certain 2004 Model Year F250/350/450/550, Excursion, and E350/450 Vehicles  
Fuel Injector Control Module Wiring Harness Repair

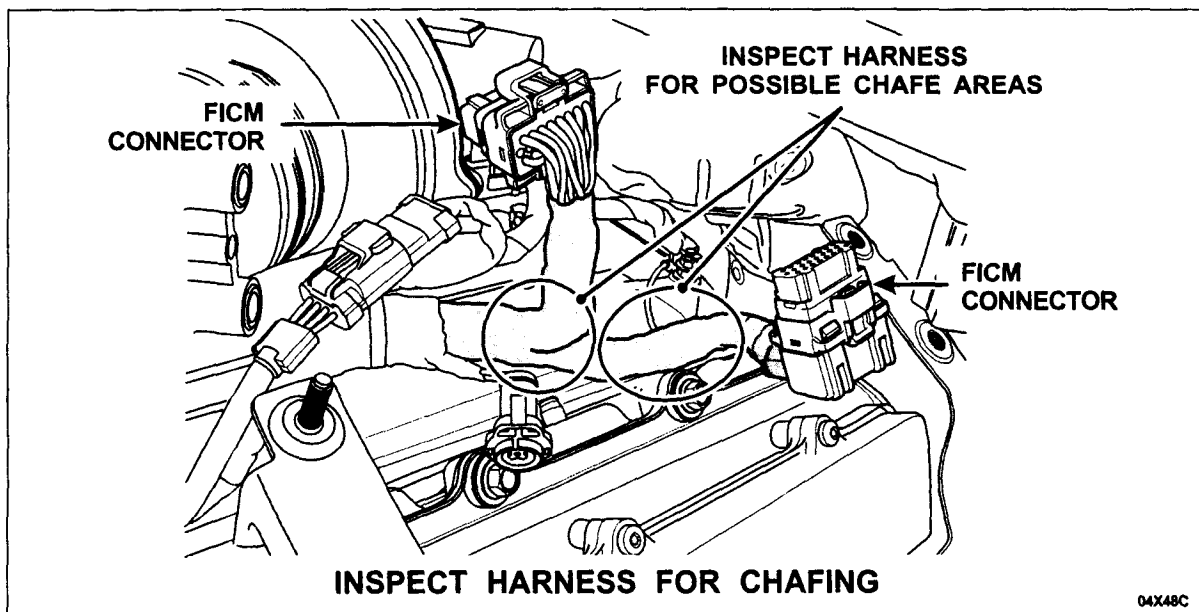
FIGURE 3

7. Inspect the underside of the injector harness in the two (2) areas noted in the illustration. See Figure 3.

- If the harness is either NOT chafed or only lightly chafed but the copper wire strands ARE NOT visible (outer vinyl tape and possibly the silver-colored shield is worn through), the Harness Protection Kit 4C3Z-14A099-A must be installed. Proceed to FICM Harness Protection Kit Installation in this Attachment IV.
- If chafing has occurred which has exposed the copper strands, the harness must be replaced. Do not attempt to repair a chafed harness if these conditions are found. Proceed to FICM Harness Replacement in this Attachment IV.

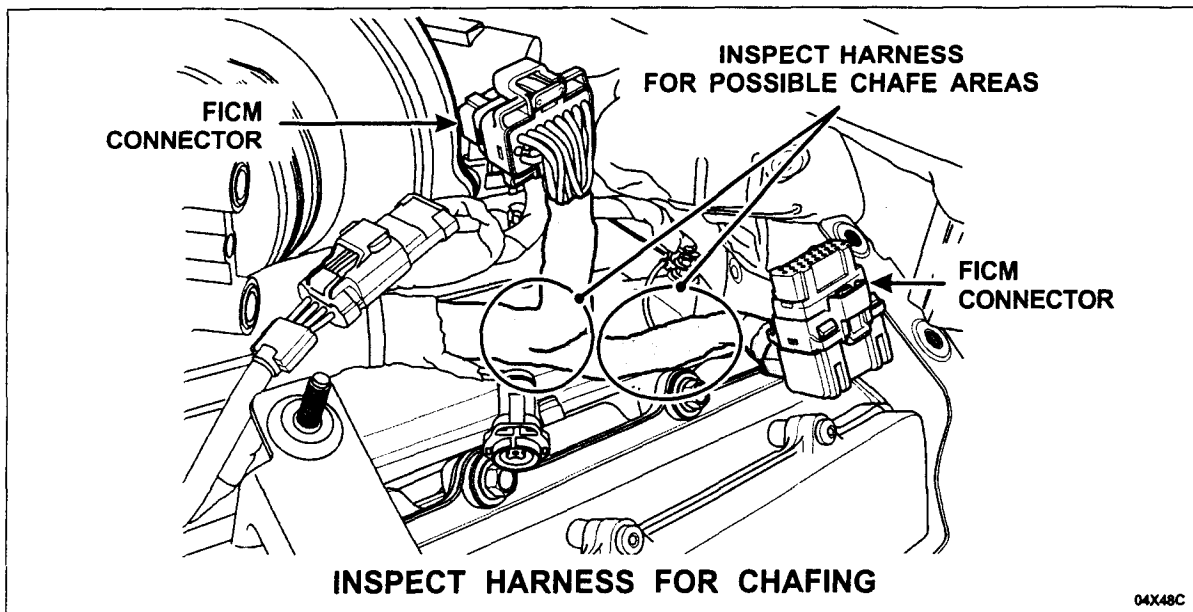
FIGURE 3

7. Inspect the underside of the injector harness in the two (2) areas noted in the illustration. See Figure 3.

- If the harness is either NOT chafed or only lightly chafed but the copper wire strands ARE NOT visible (outer vinyl tape and possibly the silver-colored shield is worn through), the Harness Protection Kit 4C3Z-14A099-A must be installed. Proceed to FICM Harness Protection Kit Installation in this Attachment V.
- If chafing has occurred which has exposed the copper strands, the harness must be replaced. Do not attempt to repair a chafed harness if these conditions are found. Proceed to FICM Harness Replacement in this Attachment V.
