Gillig Low Floor Bus Front Axle Rod Removal and Installation Procedures

It has been discovered that a small percentage of torque rod cast clamps have been cast improperly, which could result in the breakage of clamps when initially torqued. As a precaution, all torque rods with cast clamps installed on vehicles since January 2004 are being replaced with a torque rods using a clamp of a different design. The following will provide instructions on how to identify the recalled torque rods. Also outlined is the procedure for the replacement of recalled rods.

Re: Starter & Air Inlet Heater Relays

Re: Cole-Hersee Relays Part Number 51-21794-005

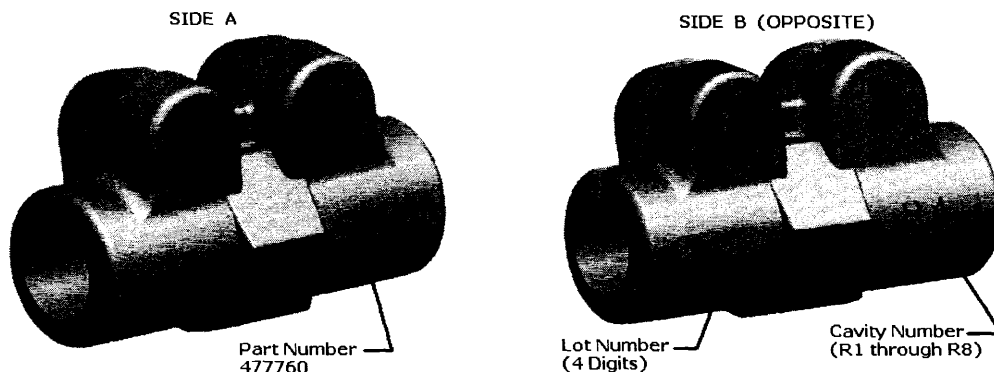
Figure 1: Clamp Identification Aid

- A list of buses by VIN that potentially have suspect clamps accompanies this notice. Only buses that match these VIN numbers will have to be inspected.
- All rods with suspect clamps will be located on the front suspension only. No rear rods are involved.
- Suspect clamps can only be identified by using the markings on the cast clamp located in the center of the rod.
- Identification should be performed while the rod is still installed on the vehicle.
- Castings are identified by a raised part number 477760 cast in them on one side and a cavity number and lot number beginning with a letter followed by 3 numbers (X_ _ _) on the other. See Figure 1.
- Some vehicles may not have any rods on them that meet the recall requirements. Others could have just one, or up to all 4 rods, that meet the requirements for replacement.

After the bus is put on a lift where the rods can be easily accessed and inspected, the suspect clamps can be identified as noted in the attached photo (Figure 1).

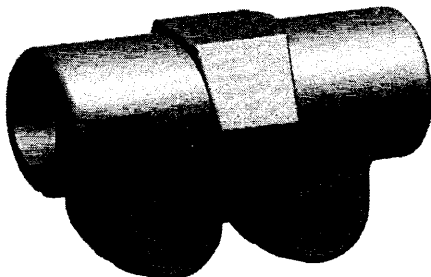
Figure 2: Identification Aid for Clamps Not Included in the Recall

Not included in the recall are rods with clamps having the part number 477762 cast in them. These clamps can also be identified with a cavity number ending in the letter S and a 4 digit numerical lot number. Unlike the recalled clamps, these clamps will have all of the identification marking cast into the part on the same side. See Figure 2

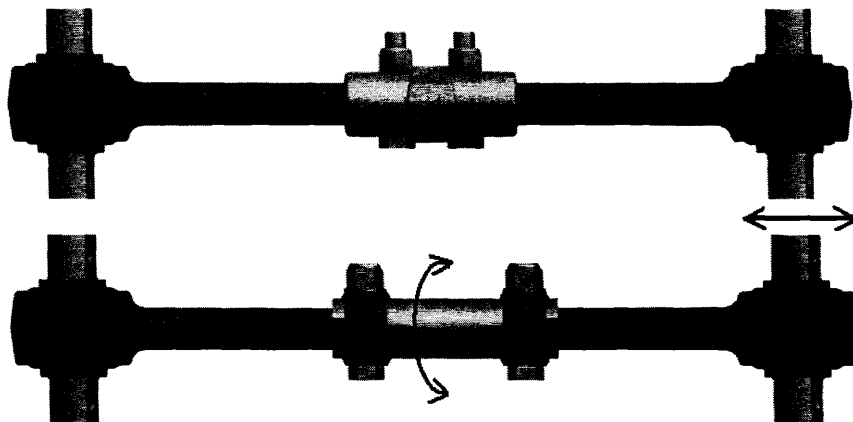
Figure 3: Procedure to adjust new rod to length of removed rod.

Note the new rod utilizes a clamp design with a machined center spacer with individual clamps on each end. Adjust the replacement rod to the same length as the removed rod by rotating the center spacer, not the rod ends. This procedure will assure that the bus alignment is maintained.

- Replacement rods will need to be adjusted to the same length as the rod it is replacing.
- Replacement rods clamps are tightened to a low torque for shipping. Loosen clamps before adjusting.
- Adjust the replacement rod by turning the clamp spacer, **not the rod ends**, until it is equal in length to the removed rod (See figure 3).
